Thompson Conservation Commission

**Interim collection of data and pictures of the
on significant barns identified in Thompson**

July 2013

Prepared by Commissioner Ron Tillen

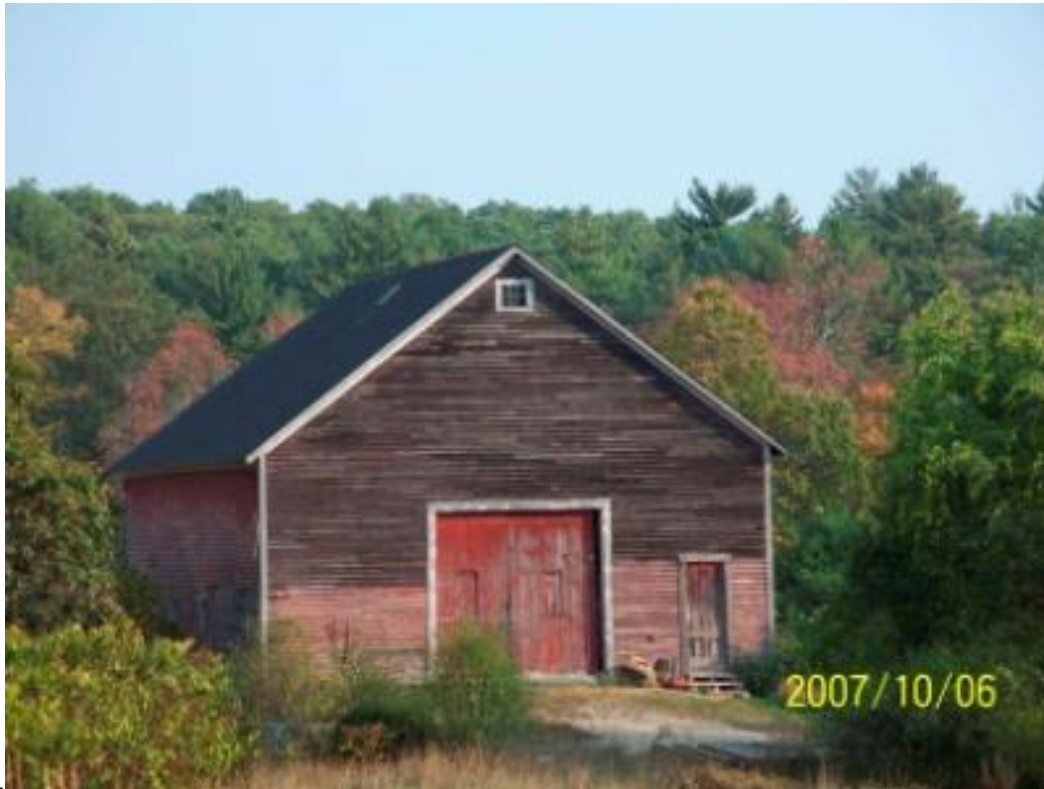
- **“No. 165” Baker Road barn**

2006 Picture and comment from prior survey. This barn is set back from the road.

Note in file states that “We started some restoration but need lots more funding to continue”.

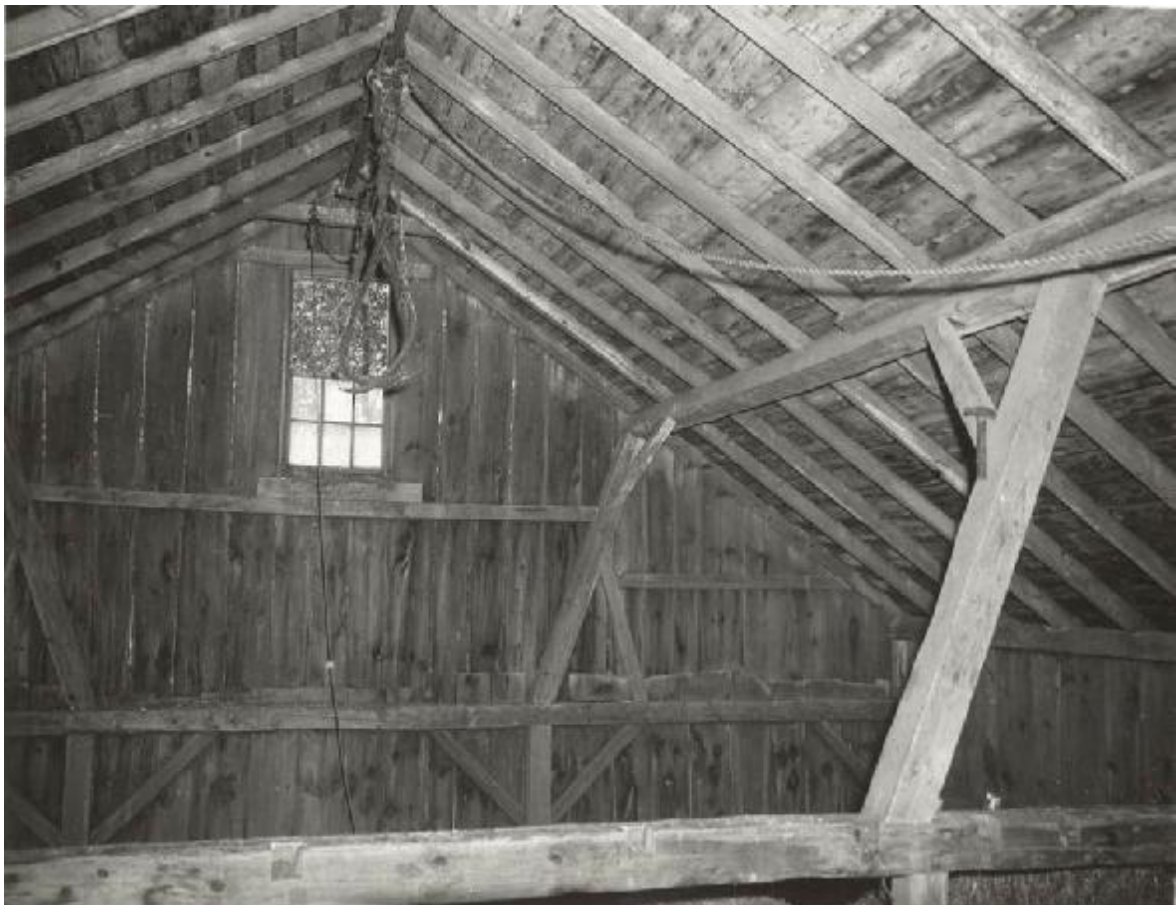
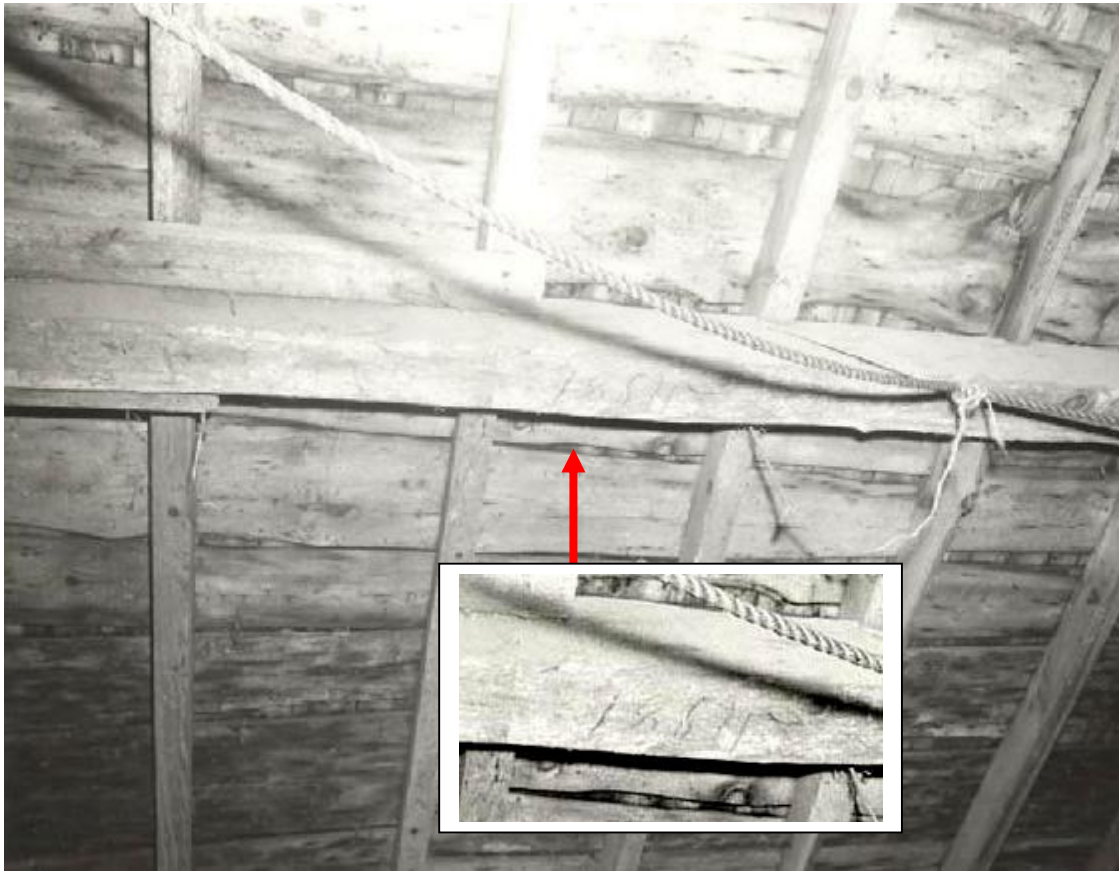
- **Babula Road “The Joslin barn” Collapsed due to heavy snow load 2011**

Inscription giving the date of J.Joslin's death

Inscription on purlin “1854” significance unknown

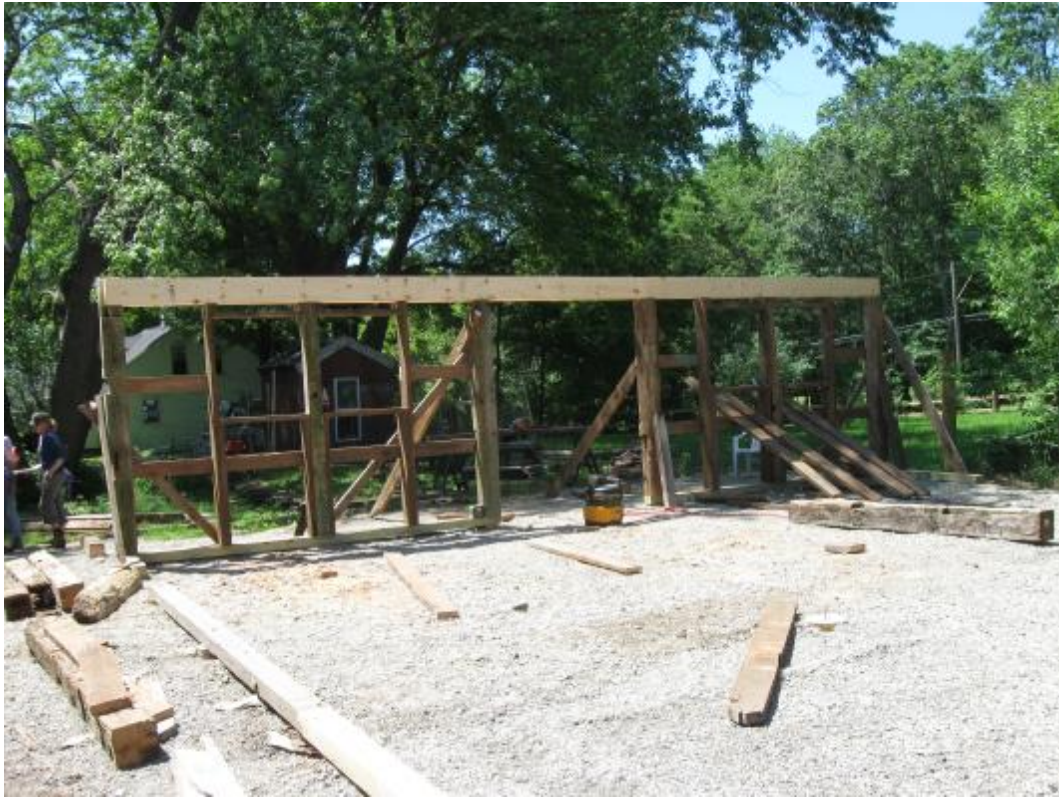
Bent erected and sills in place

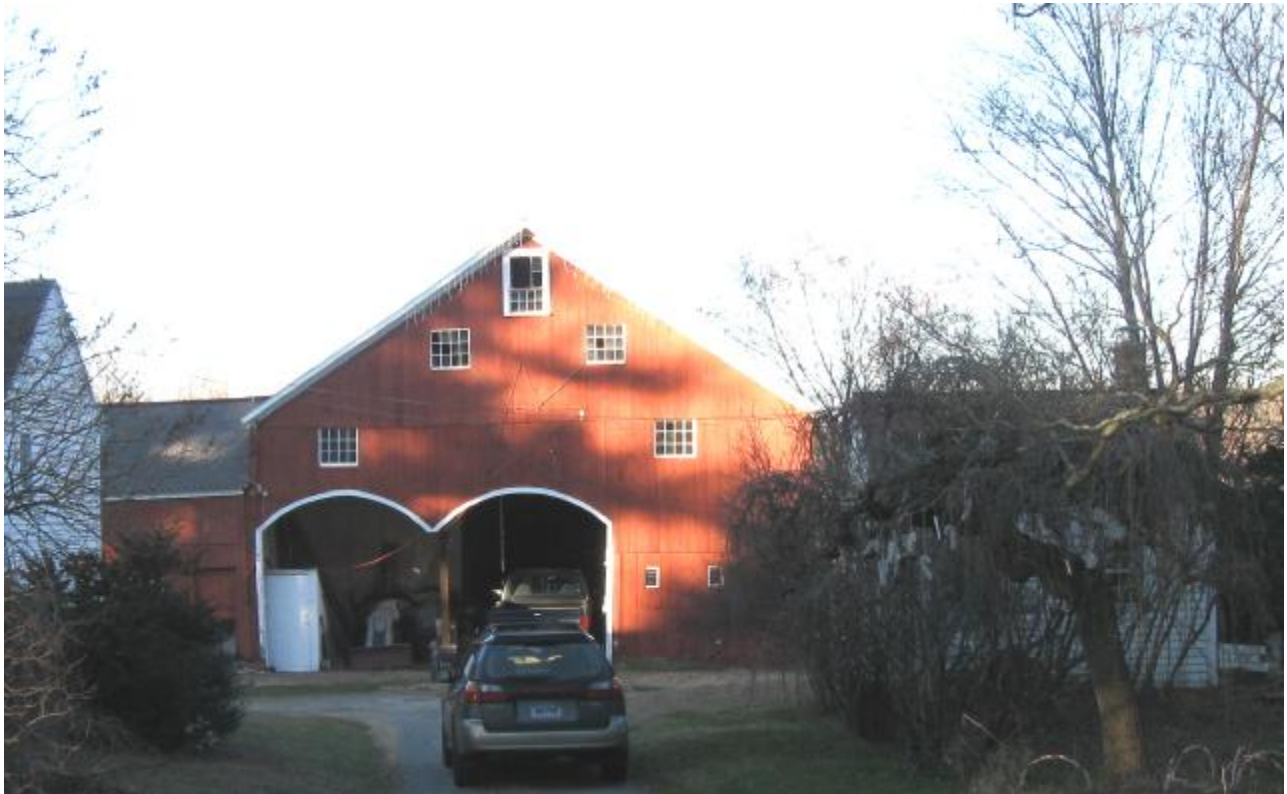
- **Haagstrom Road barn #1**

Data and B&W picture come from the prior survey Picture from the 1970s and 2011 show that this barn is used as a garage. The side building appears to have collapsed probably from the weight of snow in February 2011.

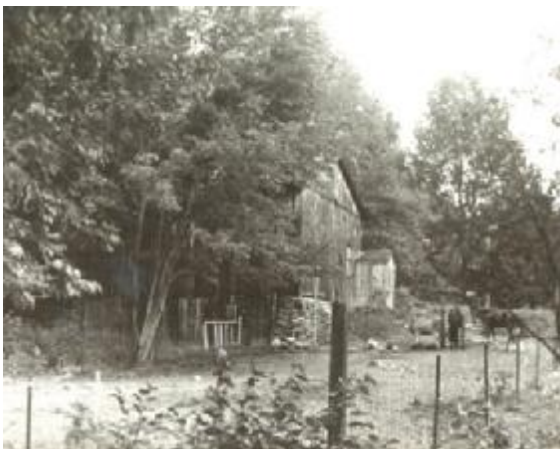
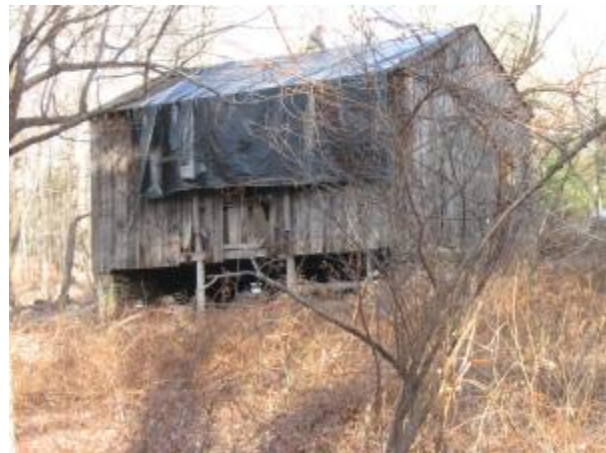
Barn #1 or #2 -- 2010 roofing in progress

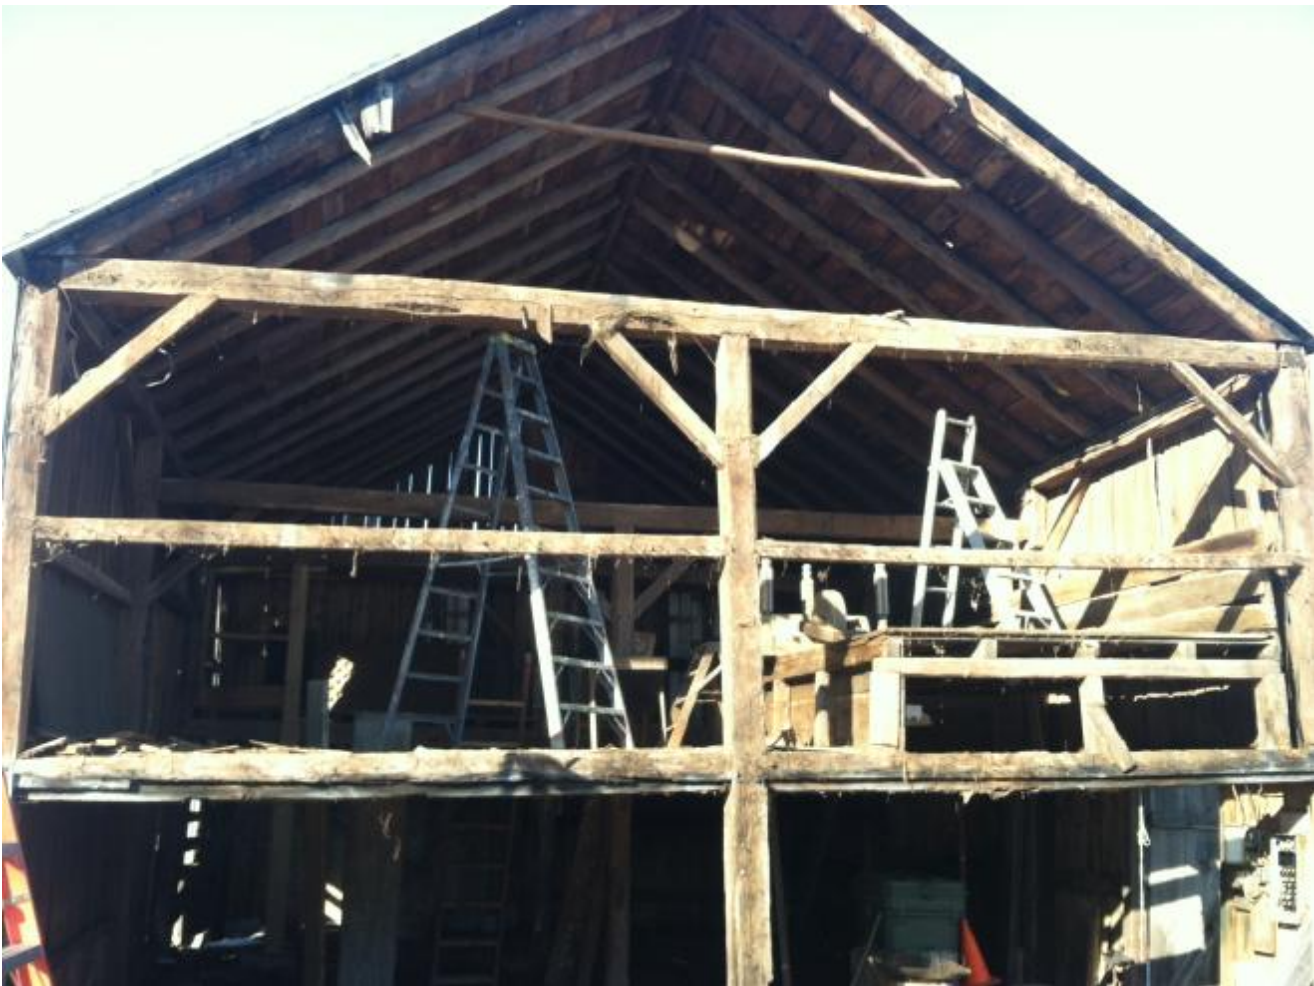
- **Porter Plain Road barn #1**

Color picture taken when barn was being dismantled by Don Hoenig ready for re-erection elsewhere.

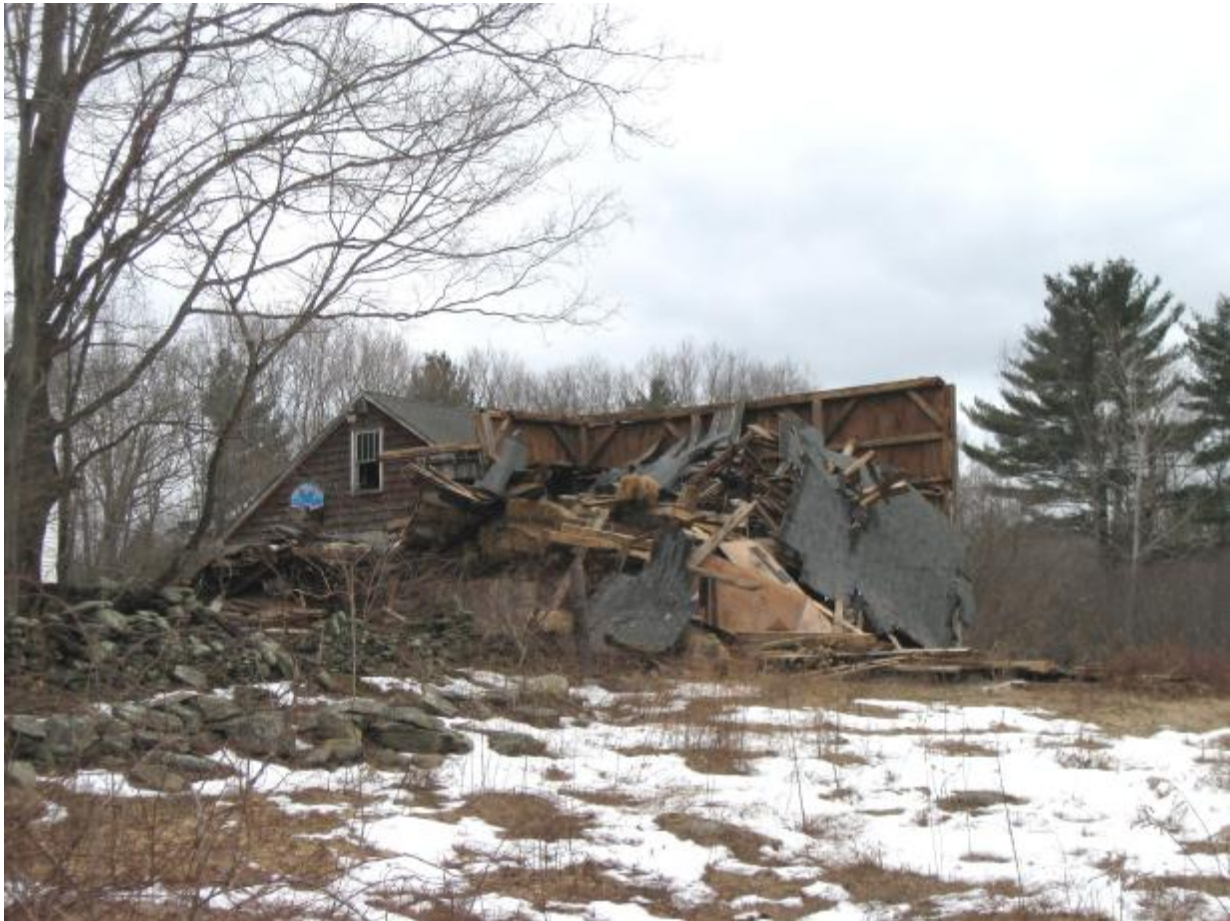
Barn collapsed under the weight of heavy snow 2011

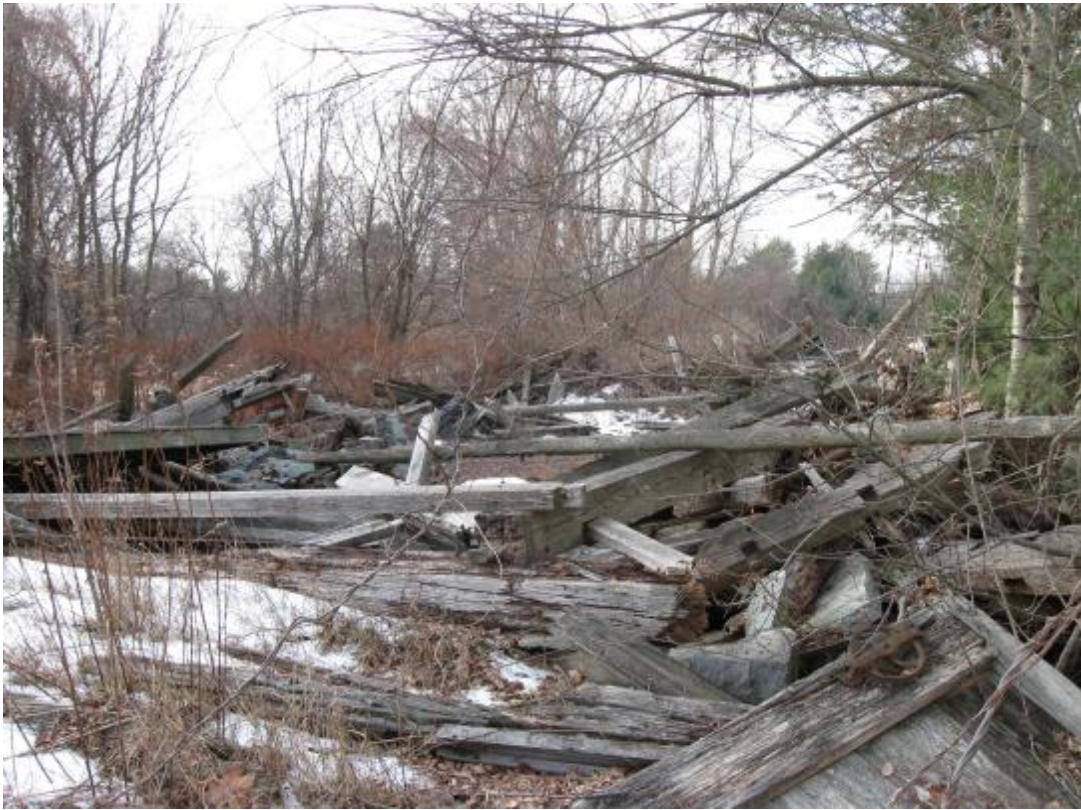
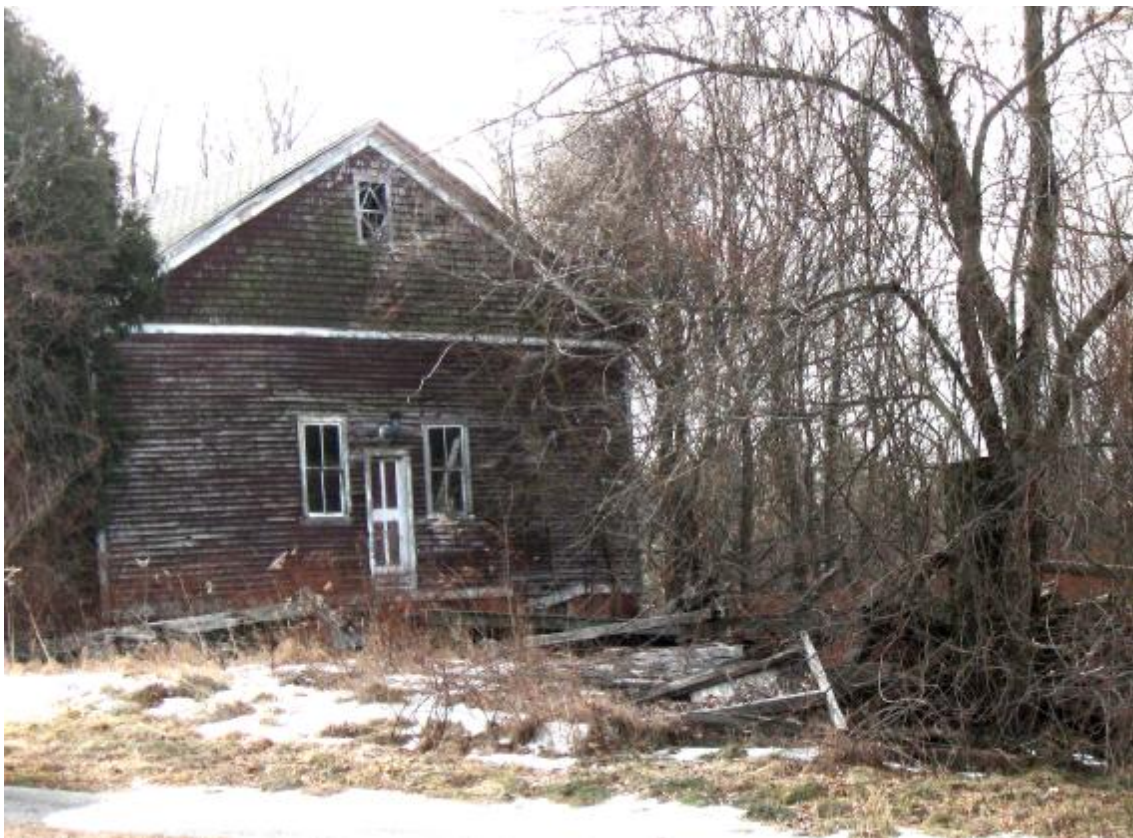
- **Route 131 barn #3. This barn has collapsed**

Above: Copy of 1970s color slide. Below: Photo in 2011 of debris from barn

Remains of barn that collapsed and barn that remains on the same site. 2010

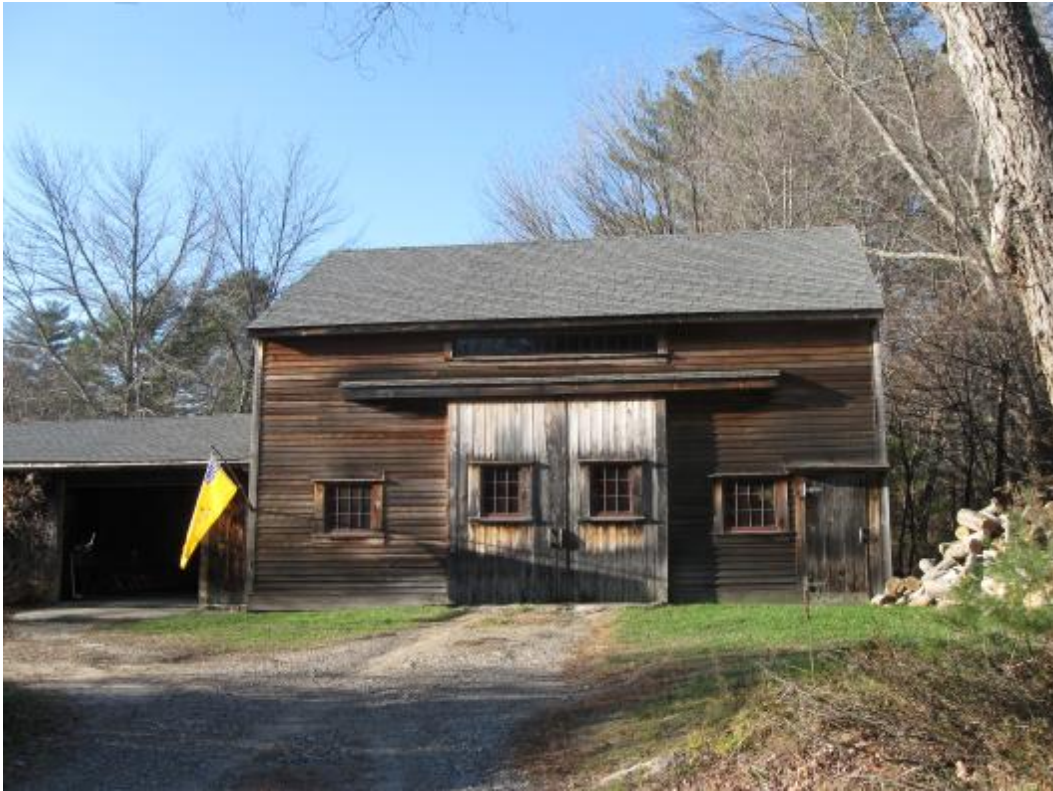
Picture taken 2011 shows changes to the door and new window on left.

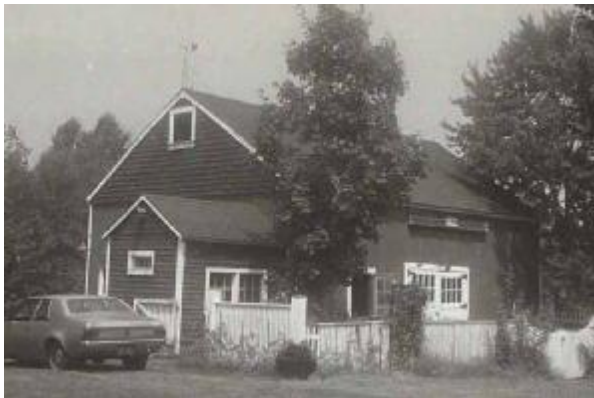
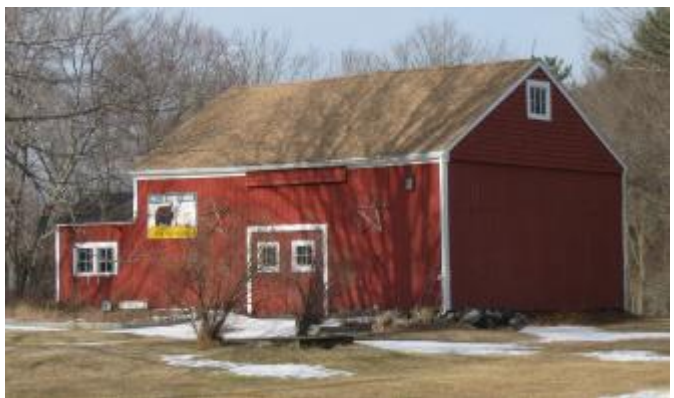
Old and new pictures show no significant change

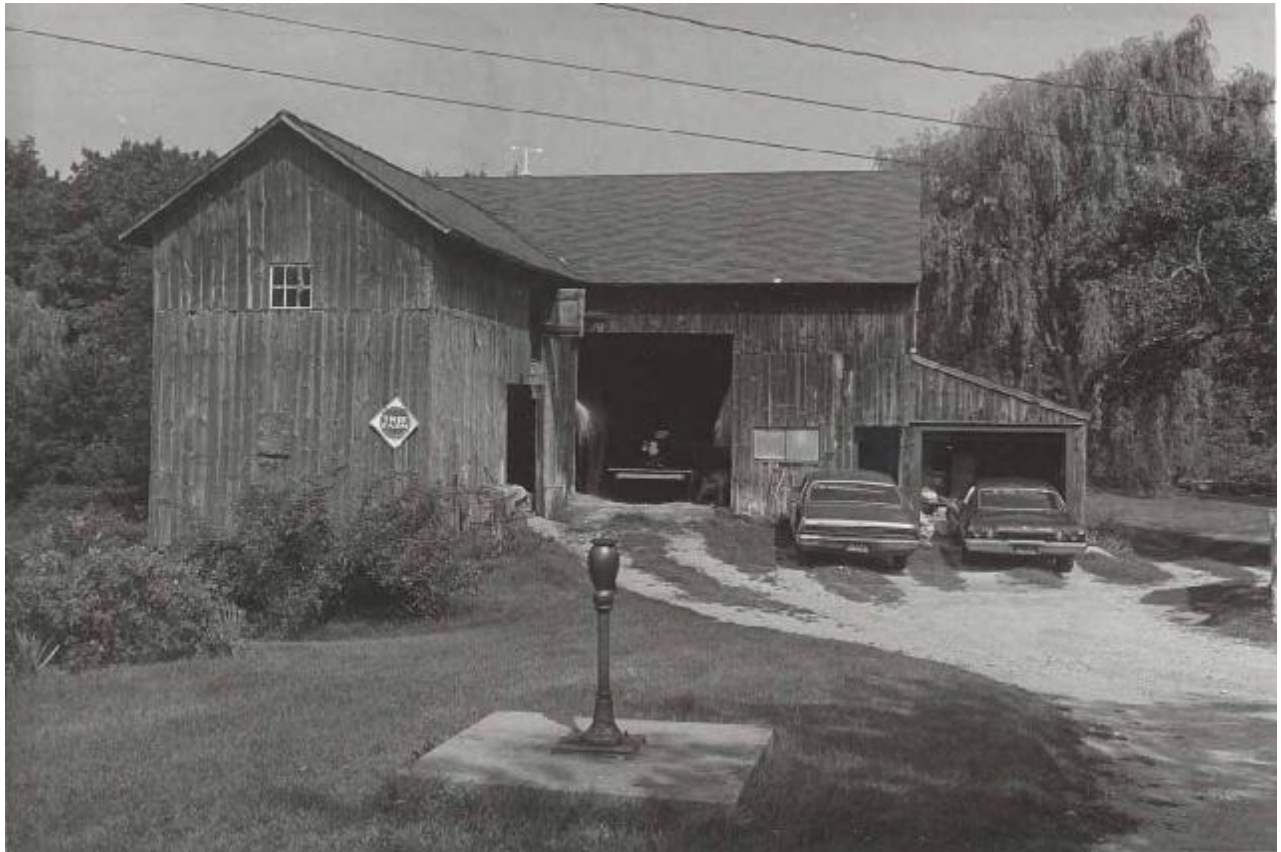
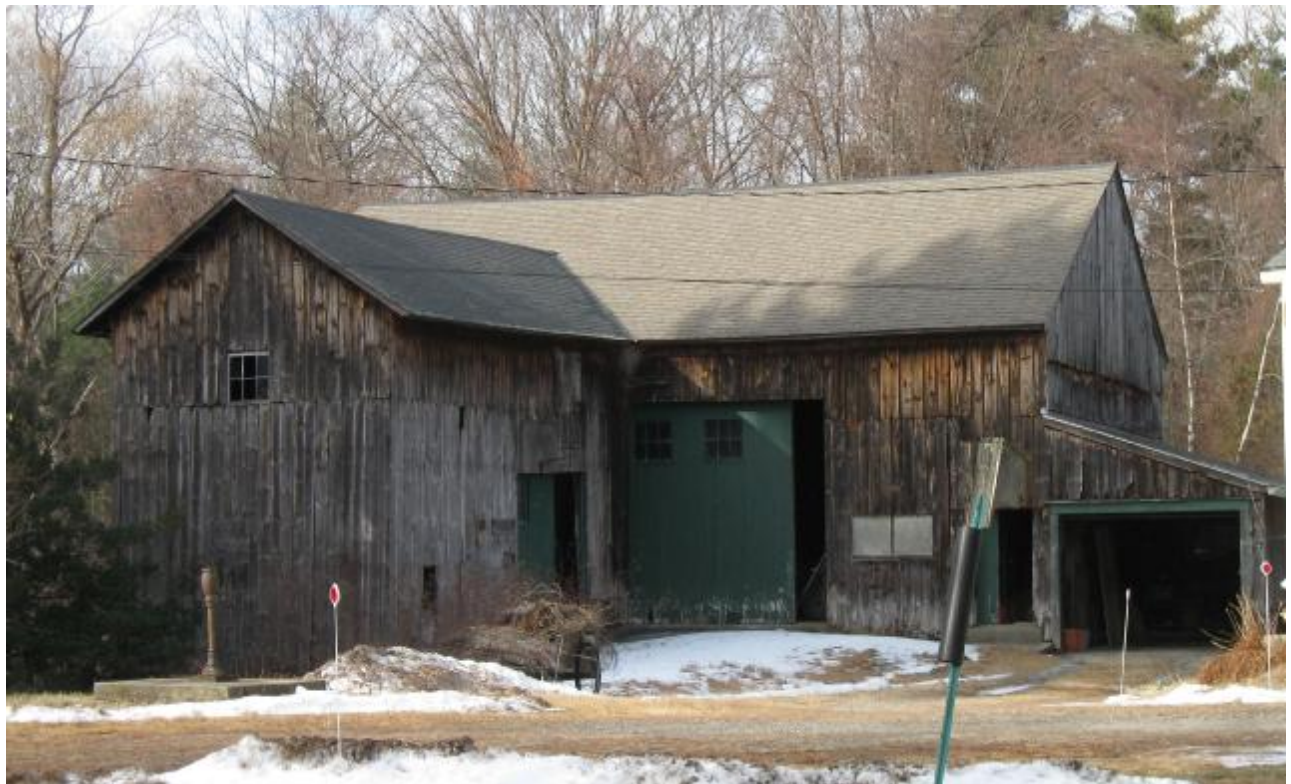
Old and new pictures showing no significant change
