## **Contract 12-05f French River Watershed-Based Plan and Implementation Action**

**Eastern Connecticut Conservation District  
August 24, 2015**

### **Task 1d – Conduct Water Sampling**

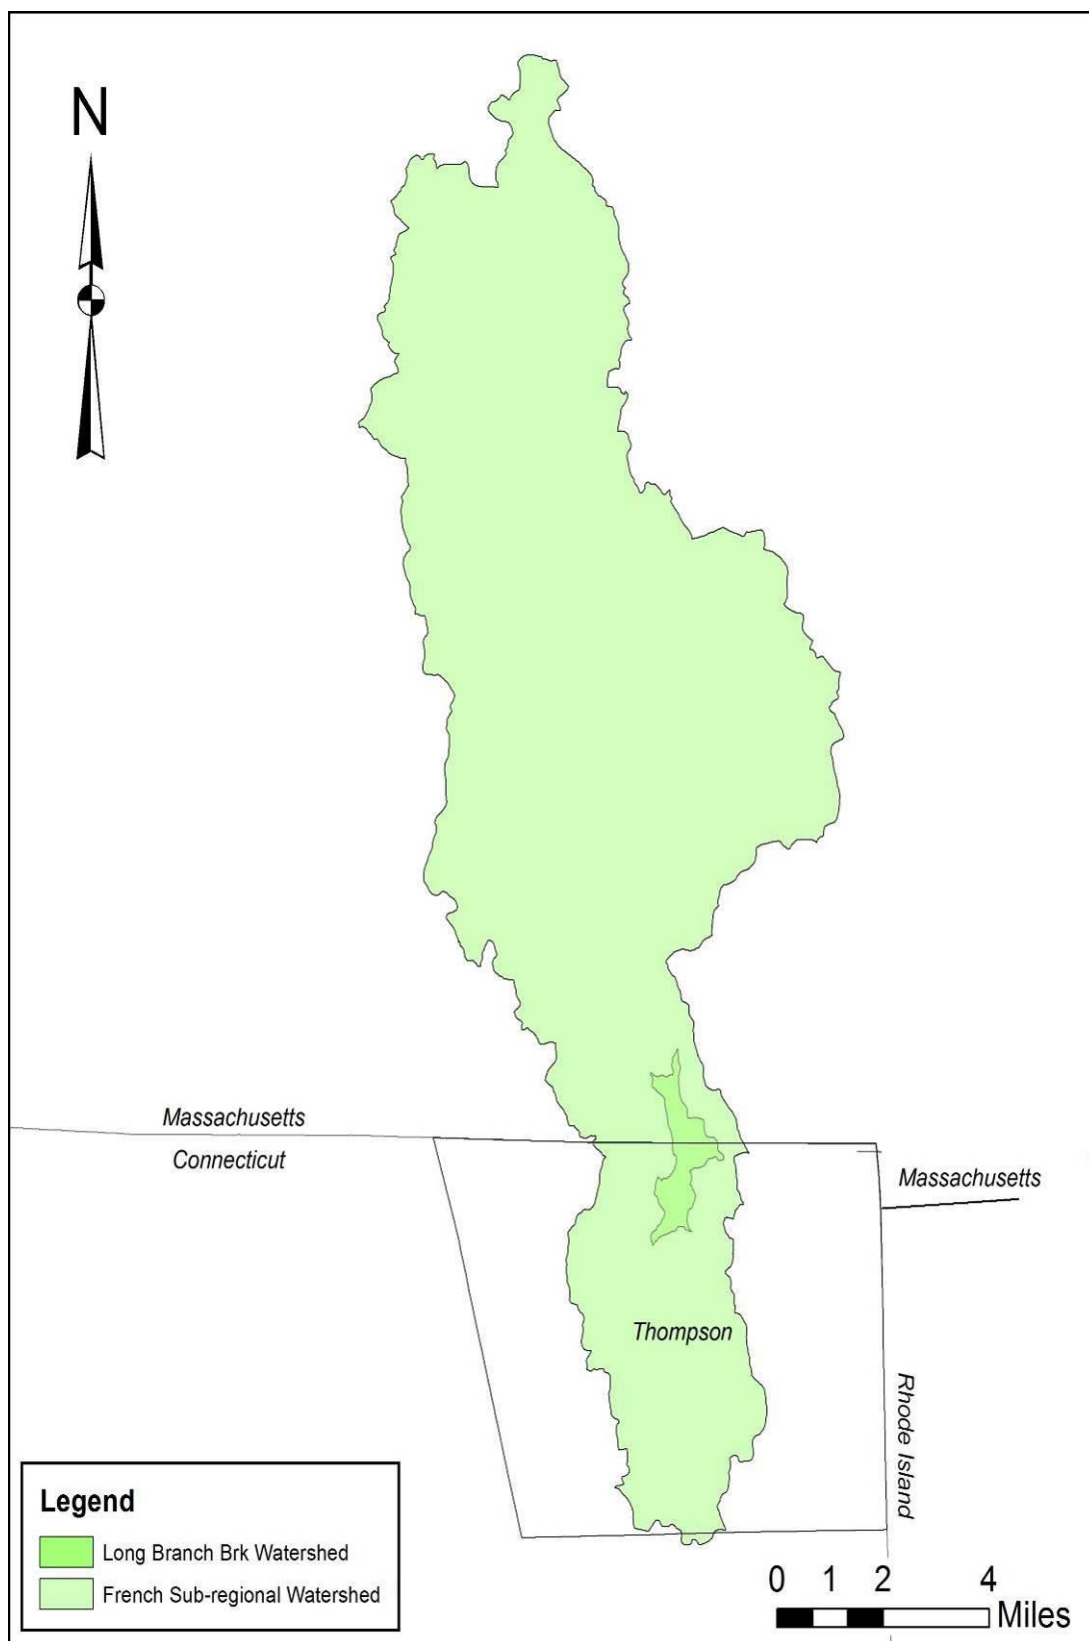
**Figure 1. The French River sub-regional watershed in Massachusetts and Connecticut. The Long Branch Brook local watershed is depicted in dark green.**

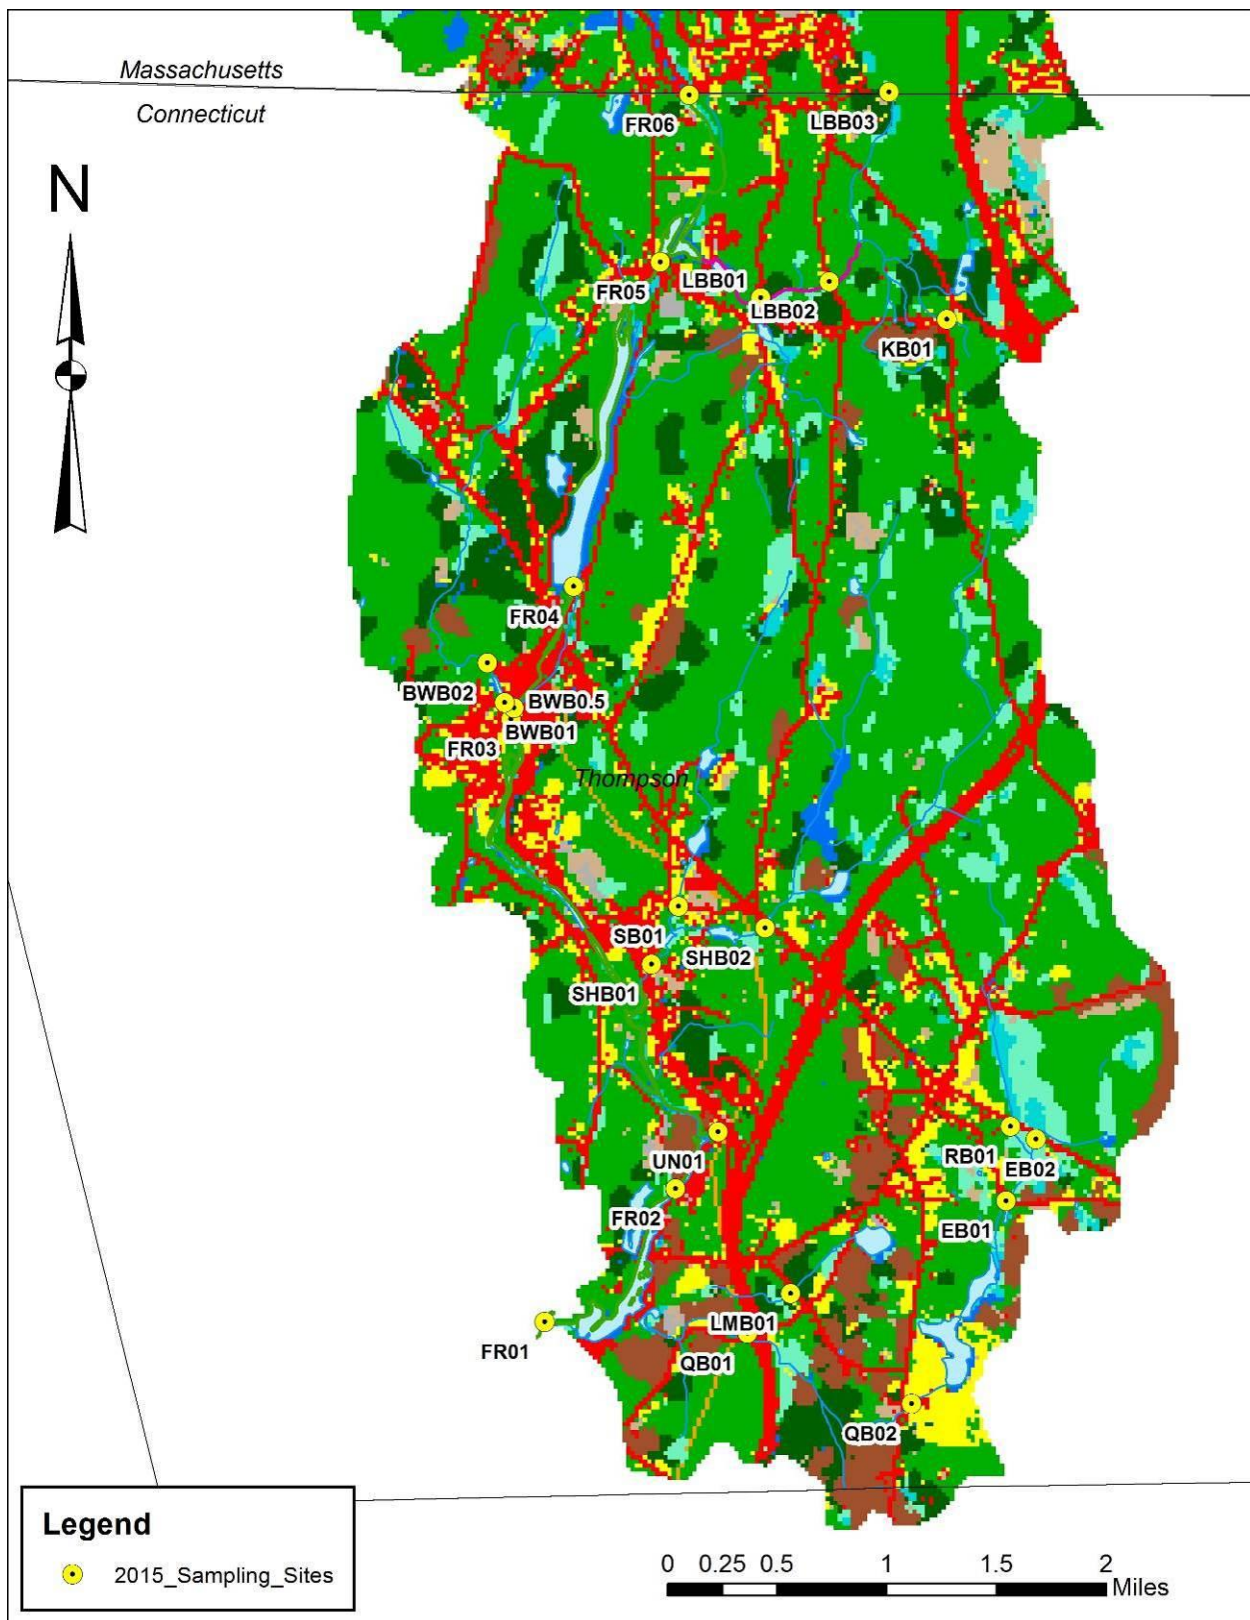
**Figure 3. French River watershed bacteria sampling sites relative to land use/land cover (CLEAR 2010).**

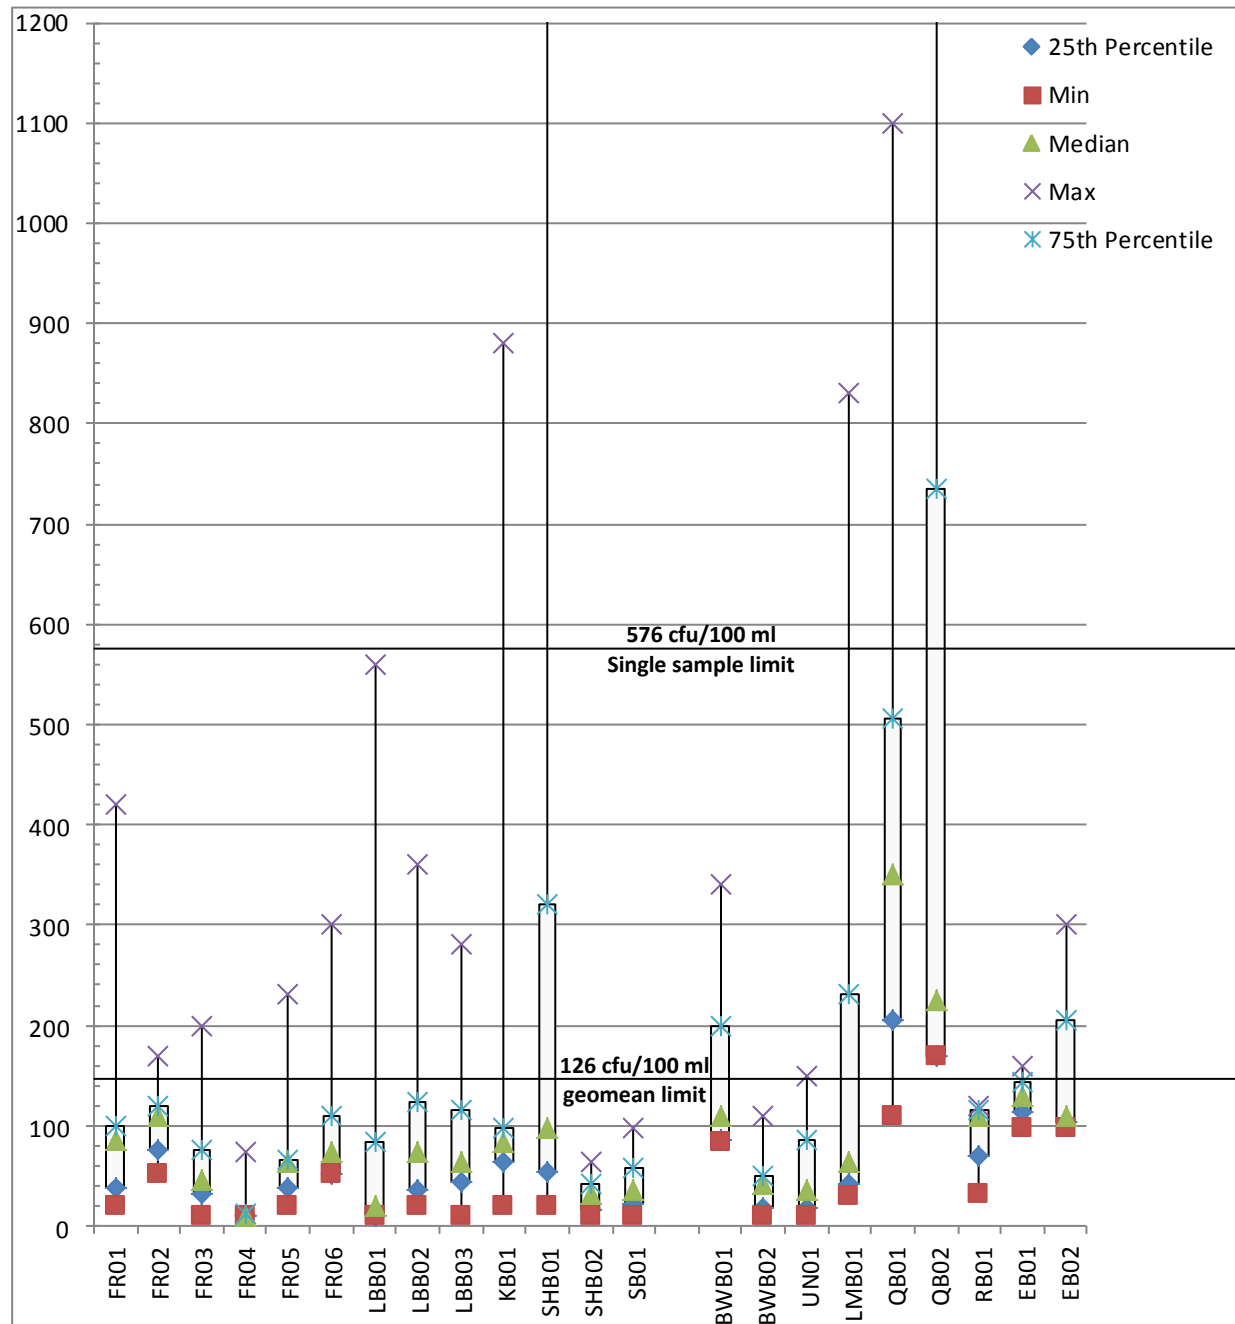
**Figure 5. Statistical distribution of bacteria results by sampling site.**

notes whether the sample was collected during wet (a rainfall in excess of 0.1 inches within 24 hours) or dry conditions. A simple statistical distribution of the sampling results was prepared, using a box and whicker plot of the data set (Fig. 5). Summaries of each individual sampling site are provided below, following Fig. 5.

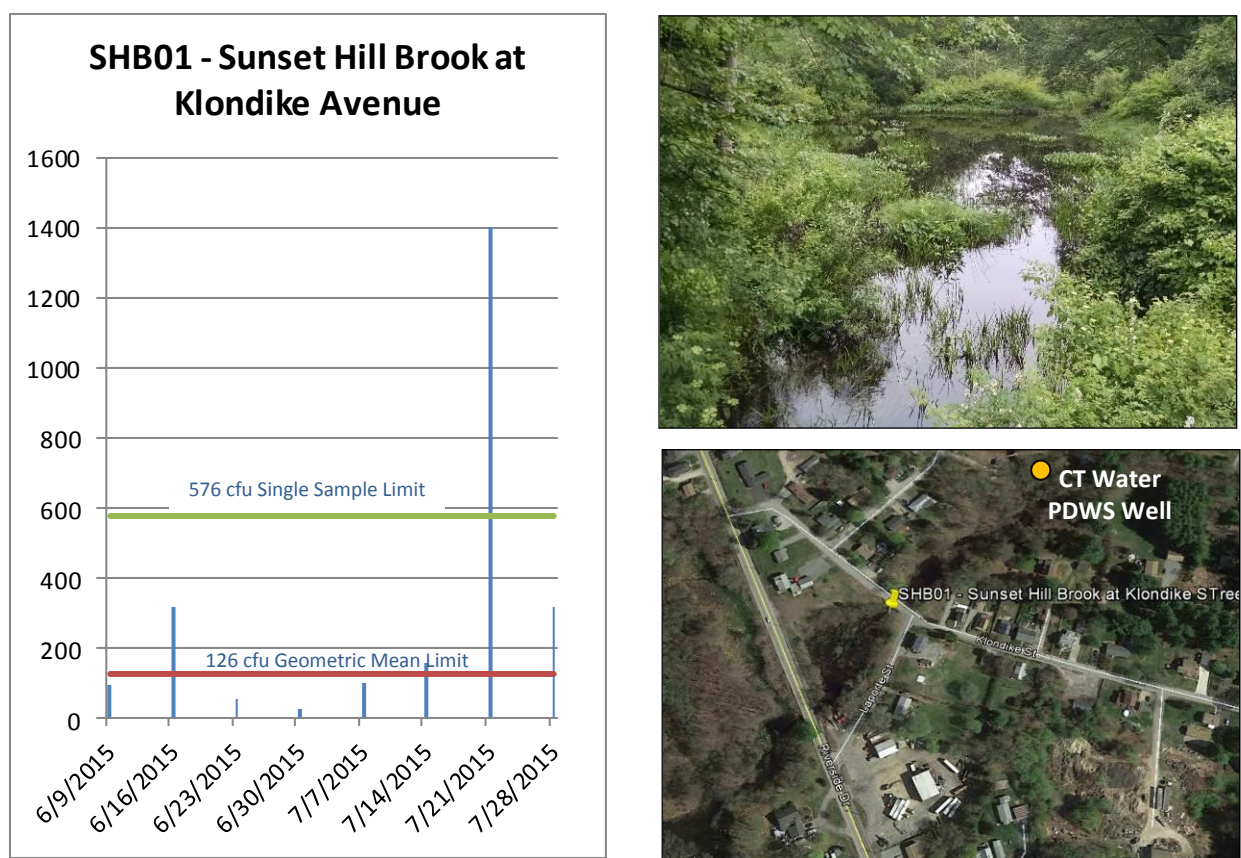
### **SHB01– Sunset Hill Brook at Klondike Avenue:**

**Figure 17. Graph of bacteria sampling results at SHB01; view of Sunset Hill Brook upstream of the sampling site; and aerial image of the sampling site location and vicinity.**

SHB01 is located at the crossing of Klondike Road with Sunset Hill Brook, approximately 700 feet upstream of the confluence with the French River. This site is also located approximately 525 feet downstream of a Connecticut Water Company public drinking water supply wellhead. This site is located in a suburban residential neighborhood which is served by municipal sewer (Fig. 6). This site was selected to document water quality contributions from the Sunset Hill Brook watershed to the French River.

Nine water samples were collected at this site, including one duplicate sample. Eight of the samples (89%) met Connecticut water quality standard of 576 cfu/100 ml for single samples. The geometric mean for this site is 124, which is within the allowable geometric mean of 126 cfu/100 ml. No bacteria reduction is required at this site.

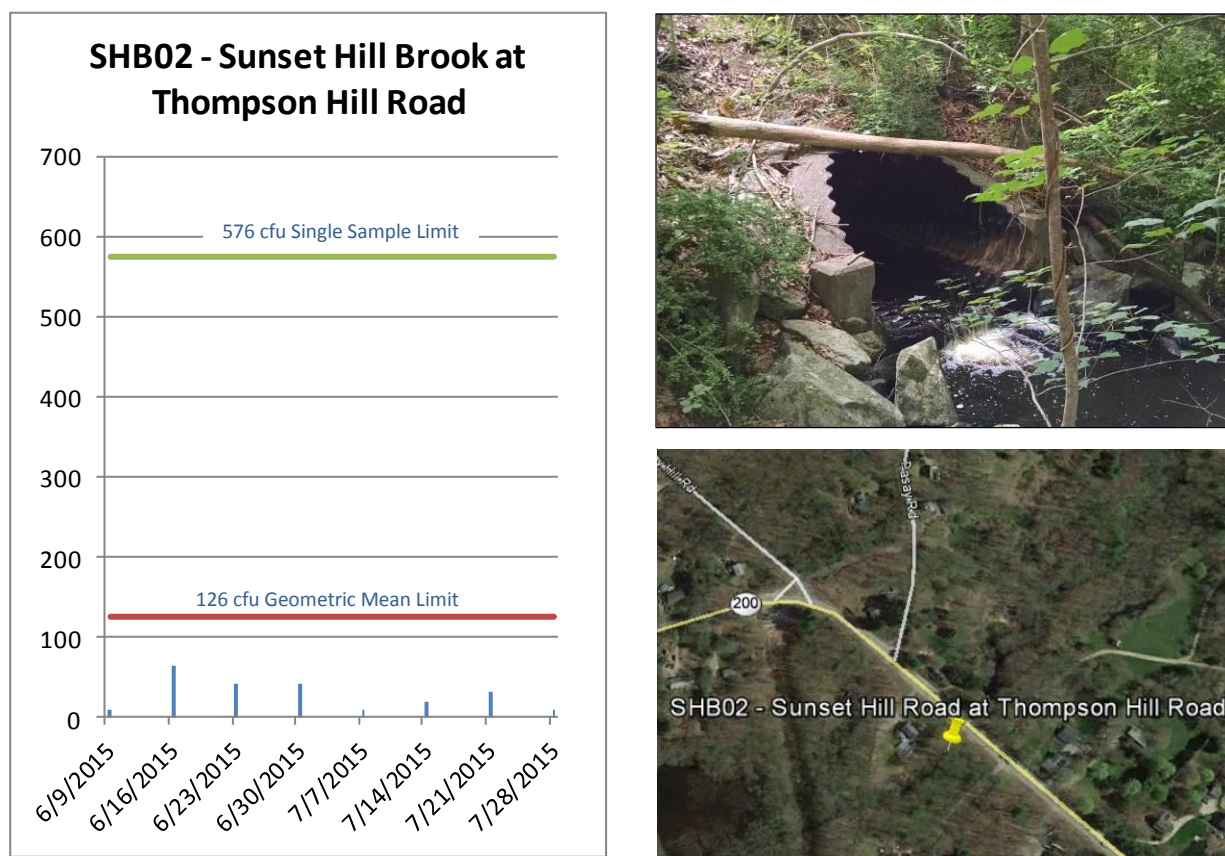
### **SHB02 – Sunset Hill Brook at Thompson Hill Road (State Route 200):**

**Figure 18. Graph of bacteria sampling results at SHB02; view of the culvert at the sampling location that conveys Sunset Hill Brook under Thompson Hill Road; and aerial image of the sampling site location and vicinity.**

SHB02 is located at the crossing of Sunset Hill Brook with Thompson Hill Road, and is located approximately 3500 feet upstream of SHB01. Sunset Hill Brook is culverted under Thompson Hill Road via a 48 inch corrugated metal pipe a distance of approximately 160 feet. The area surrounding and upstream of the sampling site and is rural residential and is primarily forested. This site was selected to potentially isolate water quality contributions from the Baptist Brook watershed and the upper portions of the Sunset Hill Brook watershed (Fig. 6).

Eight water samples were collected at this site. All the samples (100%) met Connecticut water quality standard of 576 cfu/100 ml for single samples. The geometric mean for this site is 124, which is within the allowable geometric mean of 126 cfu/100 ml. No bacteria reduction is required at this site.

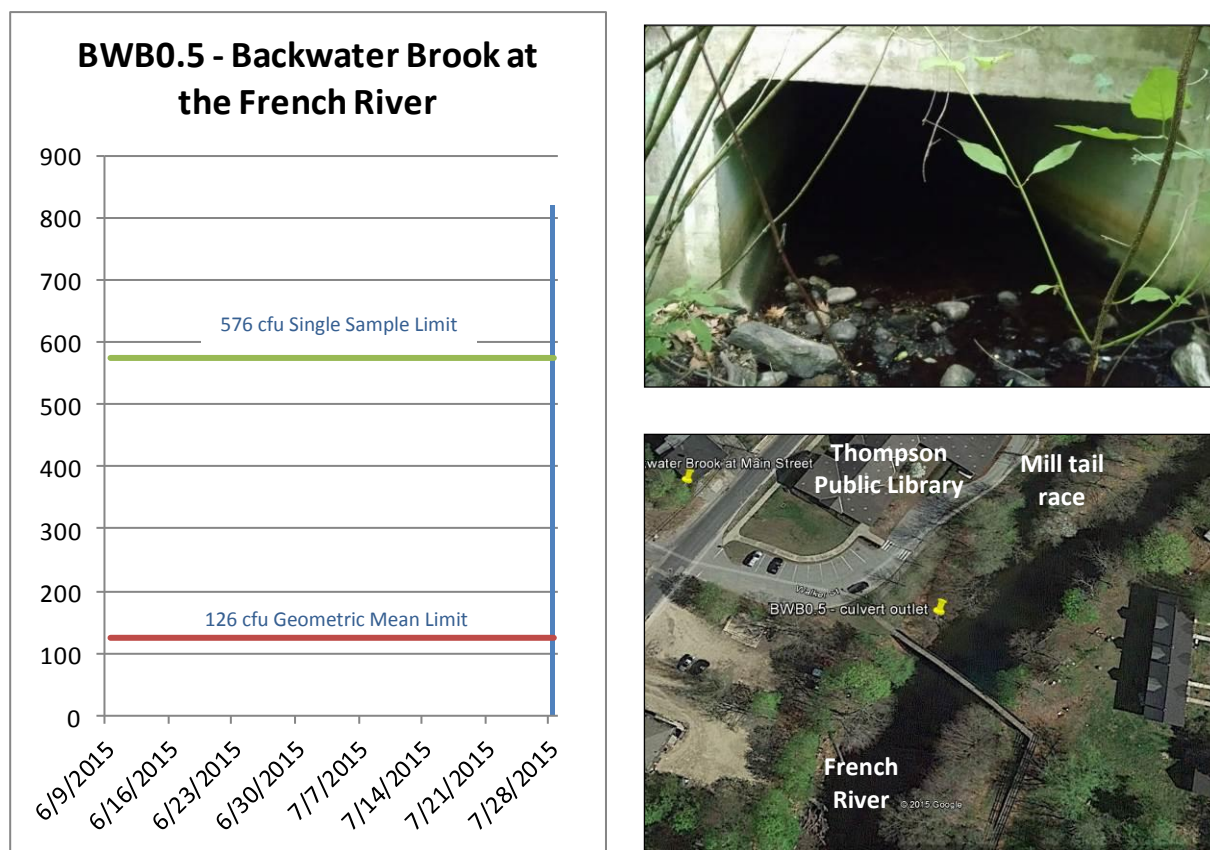
## **BWB0.5 – Backwater Brook at the confluence with the French River:**

**Figure 20. Graph of bacteria sampling results at BWB0.5; view of the culvert conveying Backwater Brook under the public library property and Main Street, just upstream of the sampling location; and aerial image of the sampling site location and vicinity.**

BWB0.5 is located at the outlet of a culverted segment of Backwater Brook, approximately ten feet upstream of the confluence with the French River. This sample was collected in an attempt to quantify water quality in response to a “sewage” odor from a nearby storm drain that is believed to discharge to this culverted segment of stream.

One water sample was collected at this site. At 820 cfu/100 ml, this sample exceeded the Connecticut water quality standard of 576 cfu/100 ml for single samples. Although only one sample was collected, an 85% bacteria reduction (based on a geometric mean of 820 cfu) is required at this site.

A single water sample was collected at a third site on Backwater Brook (BWB0.5) on the final day of sample collection (7/28/15). ECCD staff and water quality volunteers noted a foul odor emanating from a storm drain behind the library (Fig. 31). Backwater Brook is culverted a distance of approximately 250 feet under Main Street and the Thompson Public Library property, before it discharges to the French River (Fig. 31). It is believed that a portion of the storm drain system serving the library parking lot may be tied into the culverted section of stream. A water sample was collected at the outlet of the culvert to determine if discharge from the storm drain system was contributing to bacteria load in Backwater Brook. This single dry weather sample yielded a bacteria level of 820 cfu/100 ml, indicating that further investigation into the layout of the storm drain system at the library should be conducted.

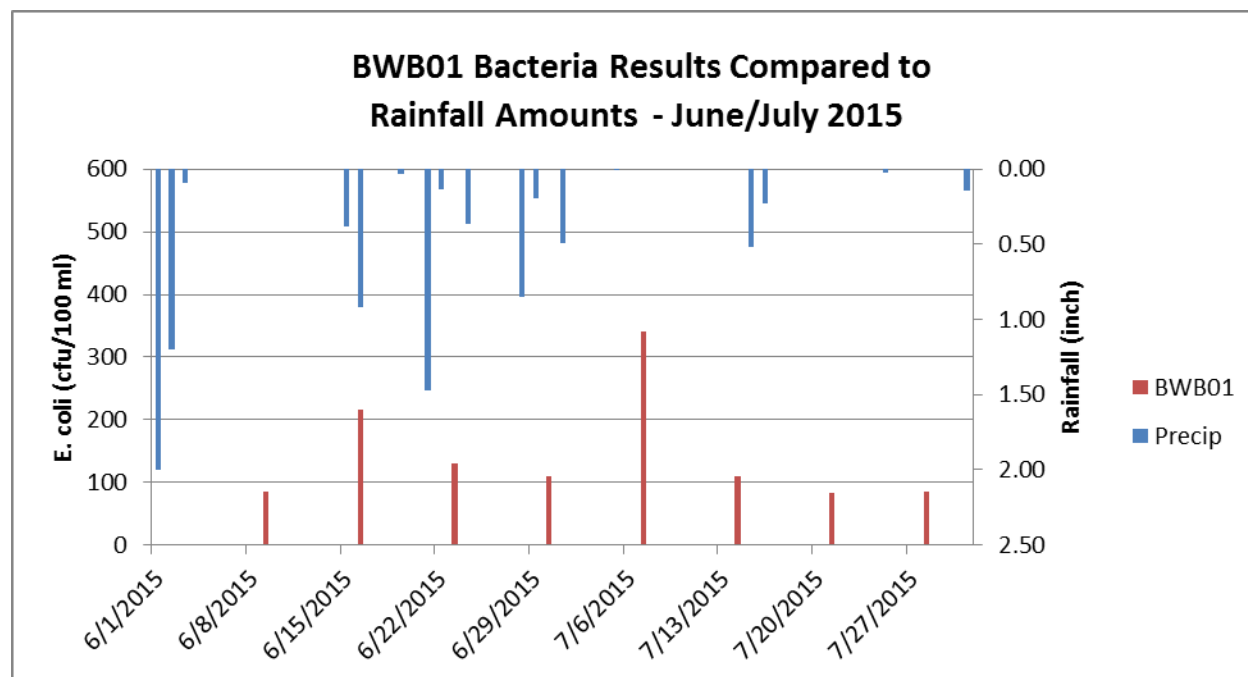
Bacteria levels at BWB01 were generally low (84 – 230 cfu/100 ml, with one higher measurement of 340 cfu/100 ml on 7/7/15). None of the samples exceeded the single sample limit of 576 cfu/100 ml. A comparison of bacteria levels at BWB01 to precipitation data collected by the Army Corps of Engineers at nearby West Thompson Lake (Fig. 30) indicates that bacteria levels spike immediately after precipitation. For example, a bacteria level of 215 (the average of 200 and 230 cfu/100 ml, the second value being a sample duplicate) was documented on 6/16/15, one day after a rainfall of 1.4 inches. In the absence of rainfall within 24 or so hours of sampling, bacteria levels in the stream water were generally low, indicating that stormwater runoff may be the primary vector for bacteria transport to Backwater Brook. The exception to this observation is a somewhat aberrant bacteria level of 340 cfu/100 ml collected on 7/7/15, during a period of dry weather. This value may be reflective of a bacteria plug from Phelps Pond due to waterfowl activity or other disturbance, or may be the result of sampling error. It should be noted that several domestic ducks were observed being kept at a property immediately upstream of the sampling site.

**Figure 30. Comparison of bacteria levels at BWB01 (Backwater Brook downstream of Phelps Pond) to occurrence of rainfall.**

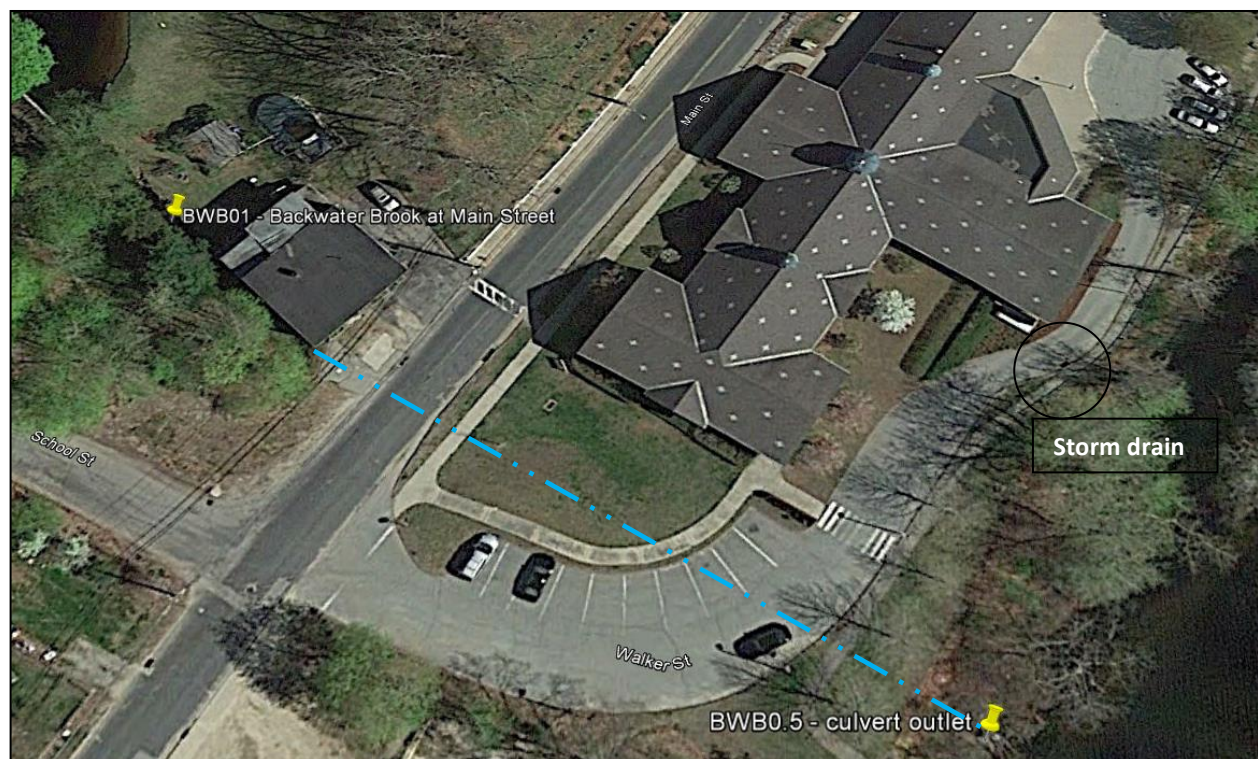
**Figure 31. Culverted segment of Backwater Brook (dashed line). Approximately 250 feet of the stream is culverted under Main Street and the Thompson Public Library property.**

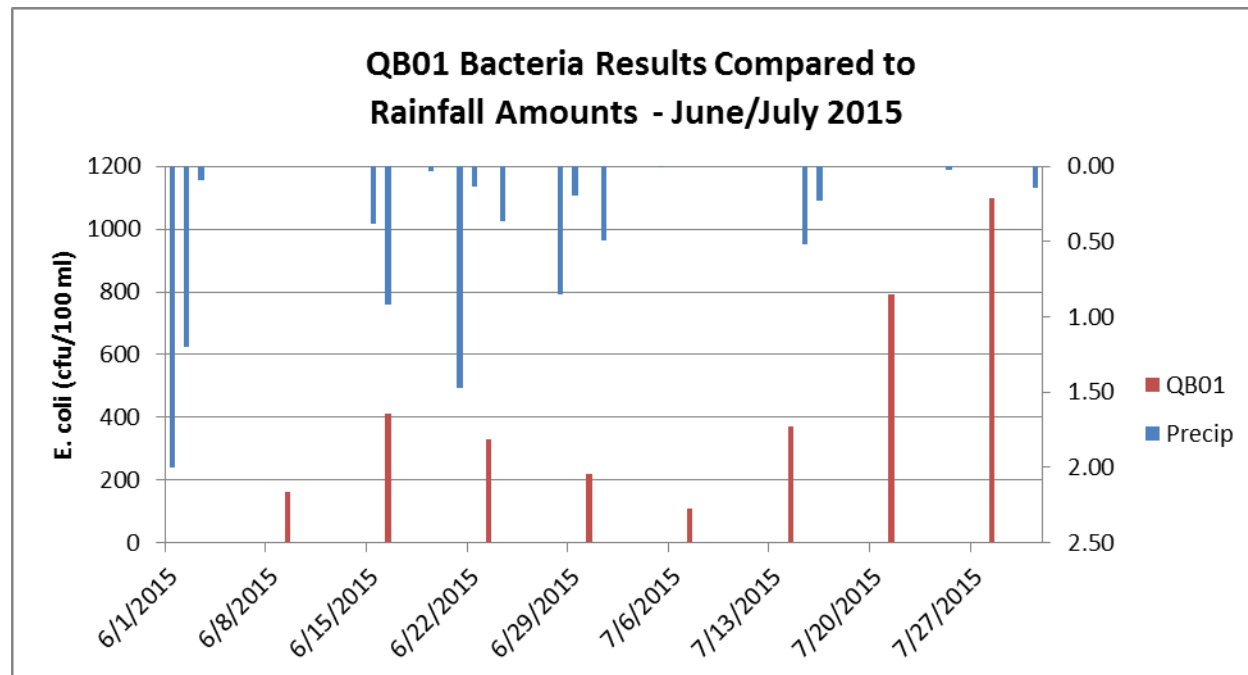
Bacteria levels in Quinatissett Brook at Ballard Road (QB01) were generally higher than those observed at other sites in the French River watershed (Table 1), and dry weather samples collected on July 21<sup>st</sup> and 28<sup>th</sup> exceeded the single sample limit (Fig. 32). Typically, dry weather bacteria spikes indicate point sources, illicit discharges or base flow-related conditions such as

septic system failures. However, there is little nearby development, so potential sources of, or contributing to, the observed bacteria levels are not immediately apparent.

**Figure 32. Comparison of bacteria levels at QB01 (Quinatissett Brook at Ballard Road) to occurrence of rainfall.**

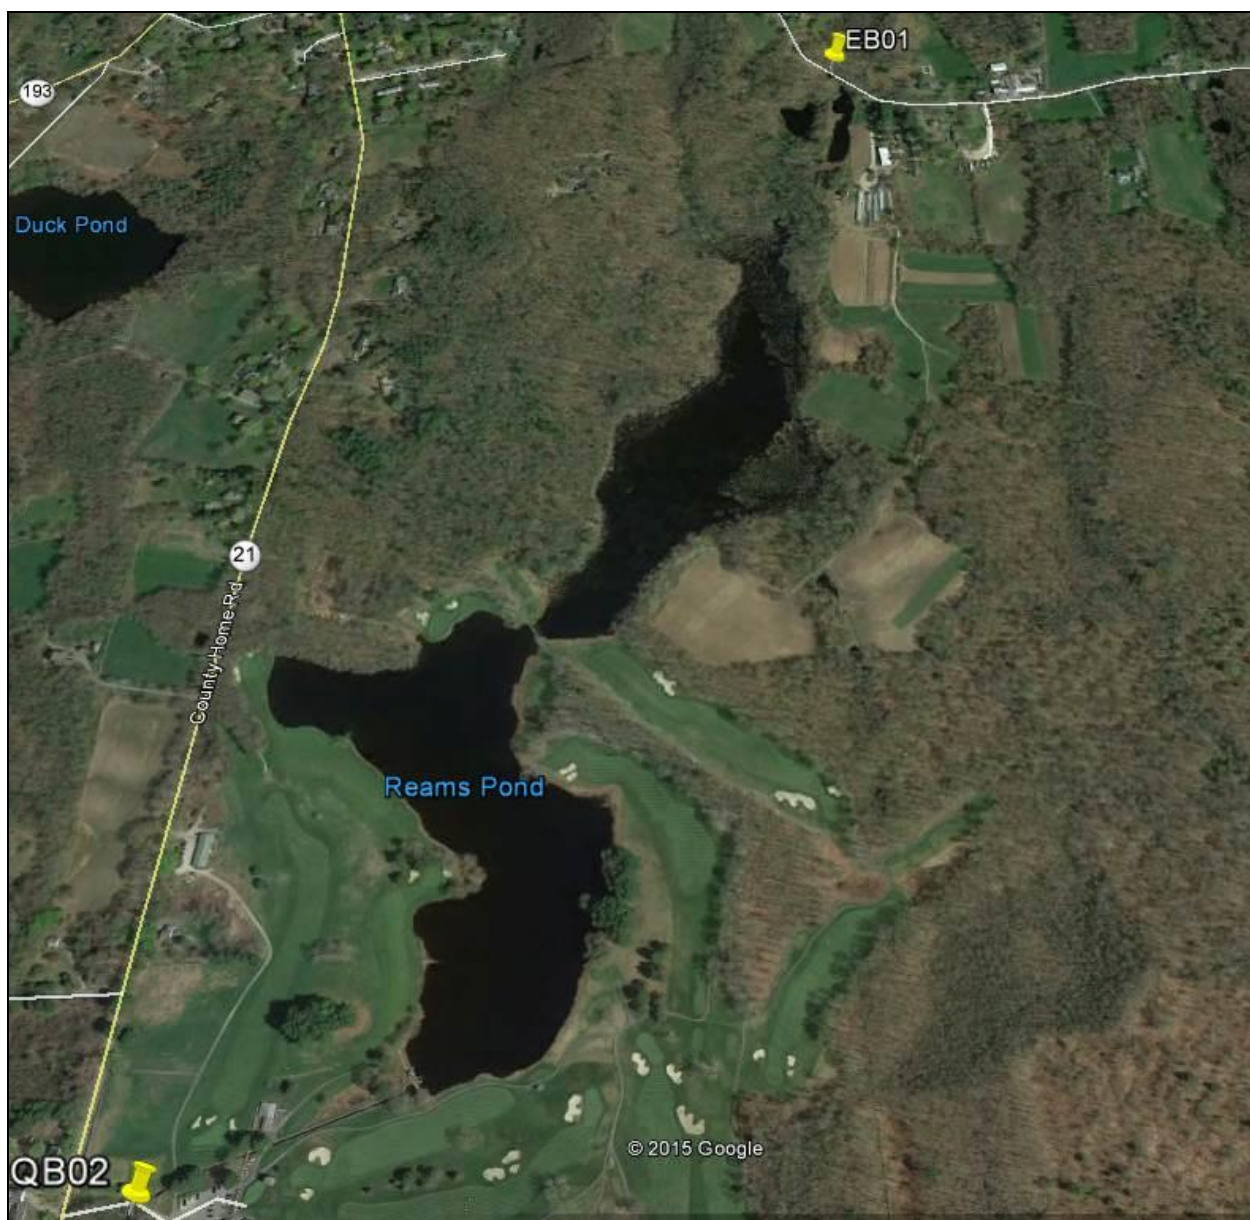
Potential bacteria sources to Reams Pond and Quinatissett Brook upstream of QB02 include agricultural land along the northeast shoreline, and Quinatissett Golf Course along the southeast, south and southwest shorelines. The shoreline of Reams Pond in the vicinity of the golf course is cleared with the greens extending to the water's edge, potentially creating attractive foraging conditions for waterfowl (Fig. 33). ECCD will follow up with golf course managers to determine if nuisance waterfowl is an issue at the facility.

**Figure 33. View of land use along Reams Pond, between QB02 and EB01.**
