Thompson Conservation Commission

**Interim collection of data and pictures of the
on significant barns identified in Thompson**

July 2013

Prepared by Commissioner Ron Tillen

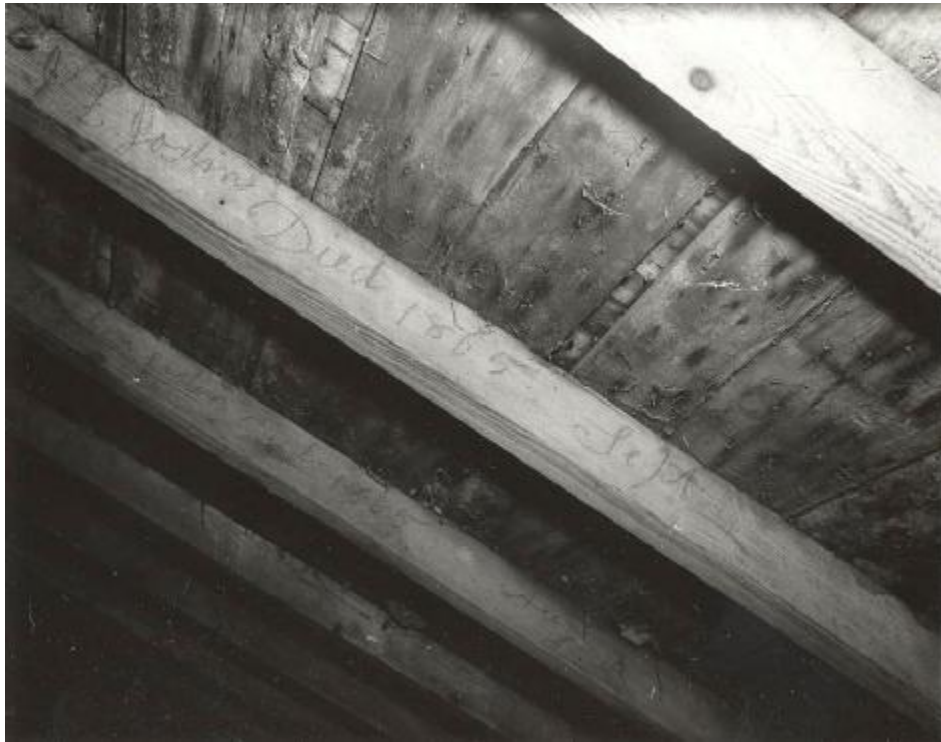
Inscription giving the date of J.Joslin's death

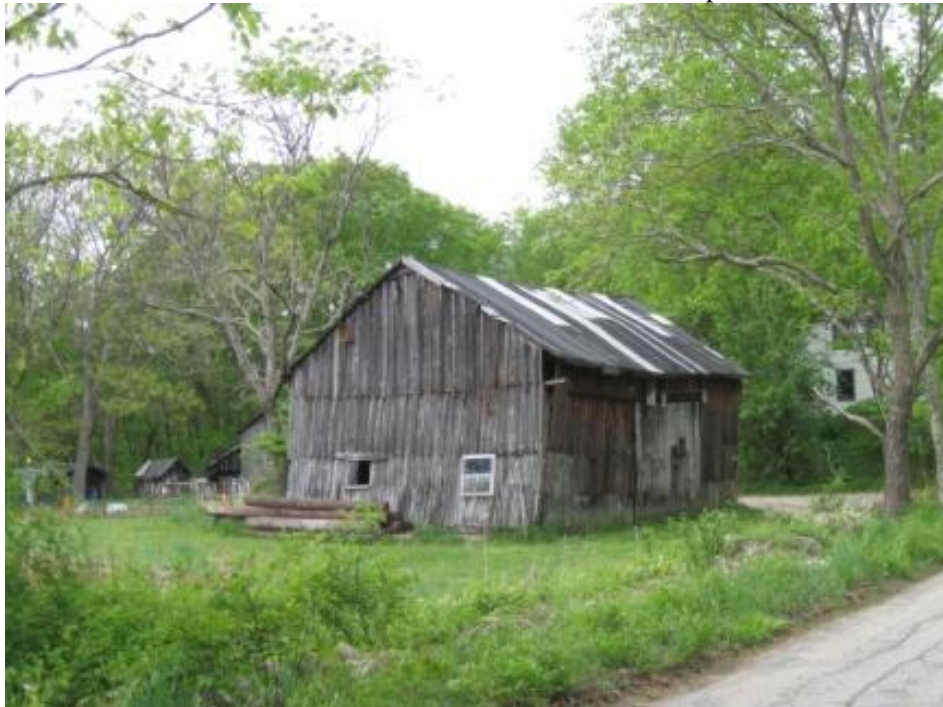
Picture taken 2010. This barn is in bad shape.

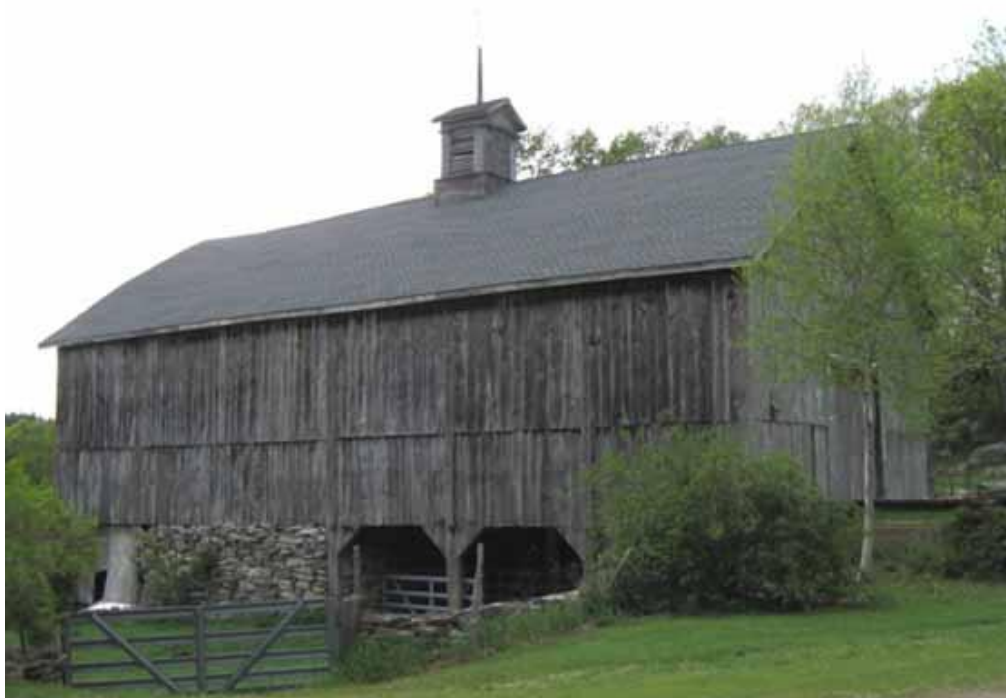
The barn is at the verge of the US Corps of Engineers flood plain

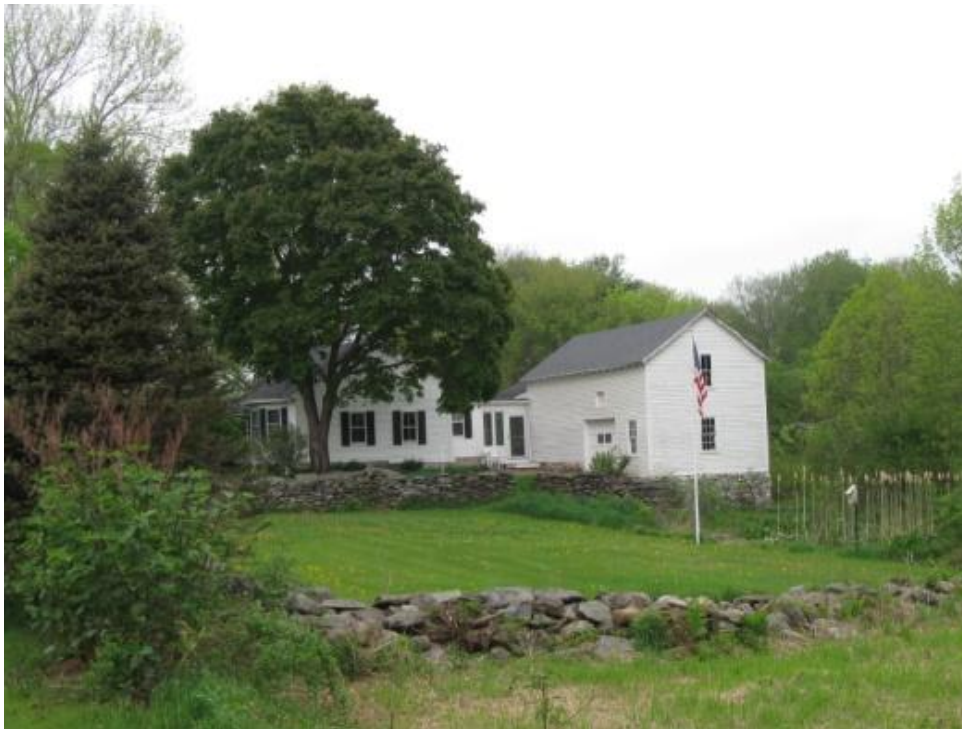
- **Chase Road McGarry house has a small barn attached to house**

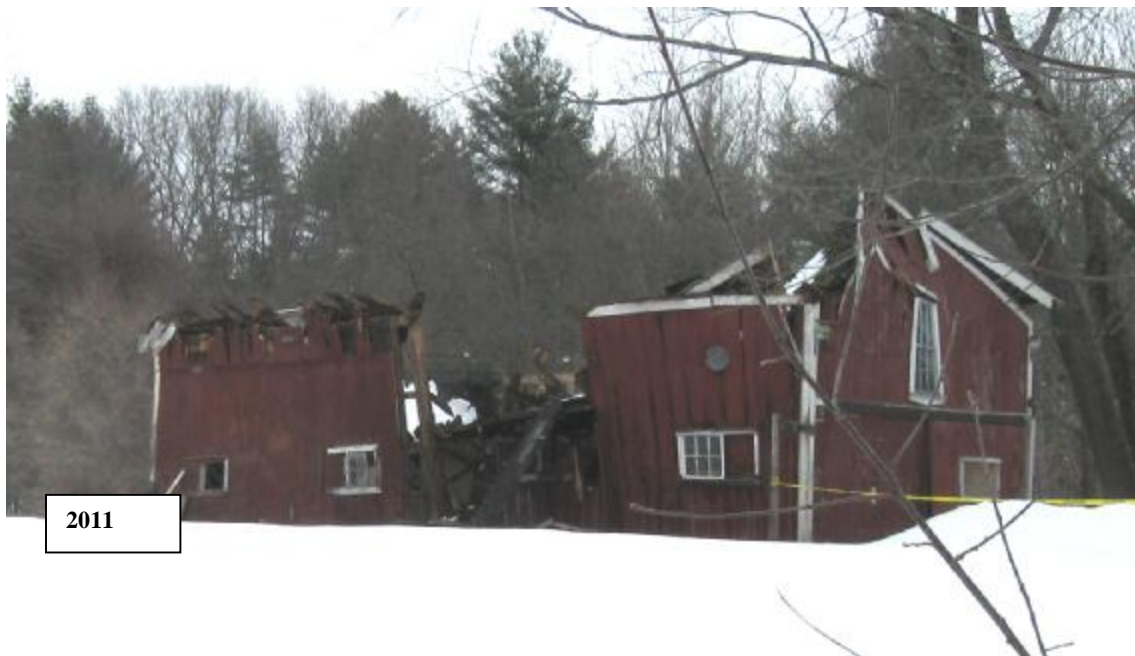
- Chase Road near Hill Road –collapsed due to snow on roof Feb.2010

Morgan quarter horses were once reared on this farm

A new barn has been erected in 2012 on the site of the collapsed barn using some of the old chesnut timbers.

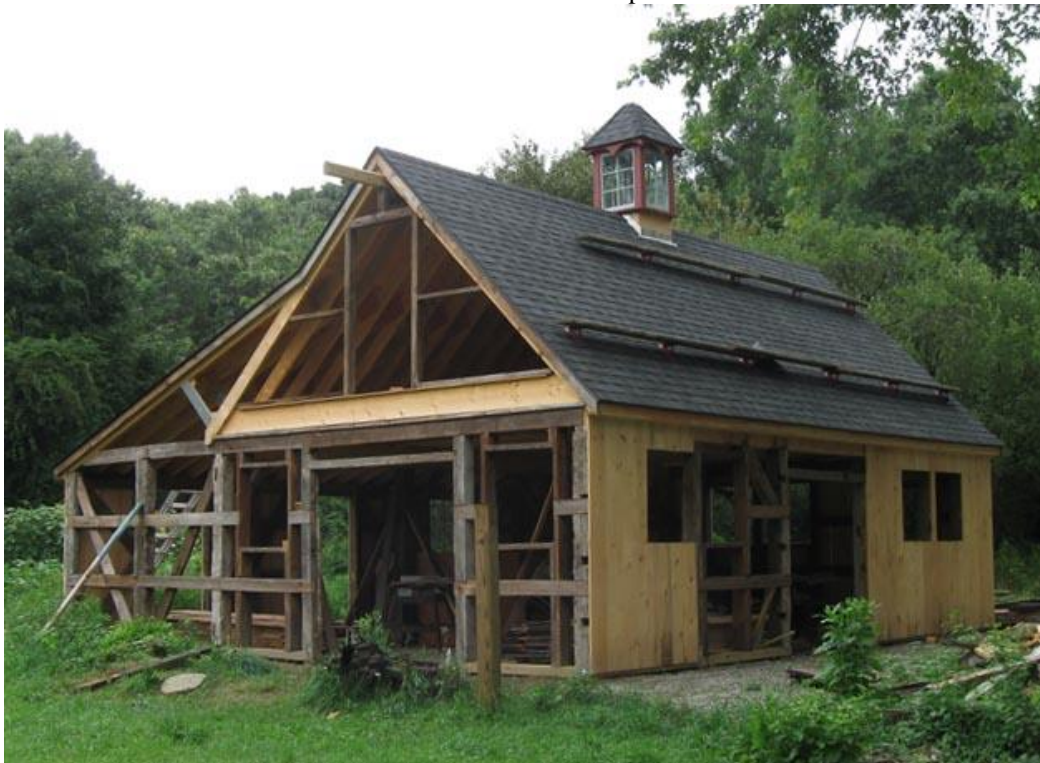
Roof in place, cupola added and barn is ready for siding

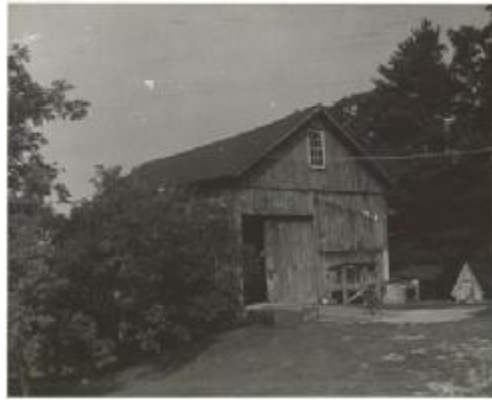
- **East Thompson Rd. Barn #1**

Possibly located near New Road and burned down at the same time as the house.

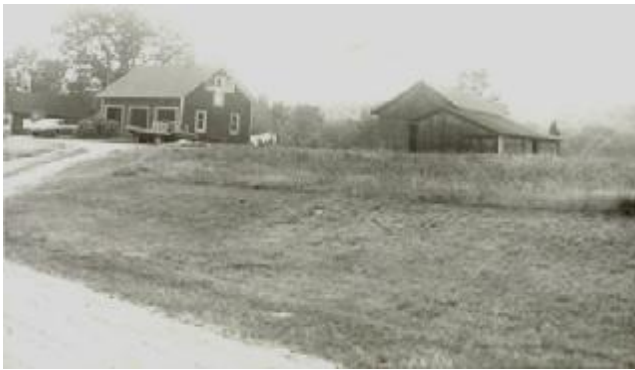
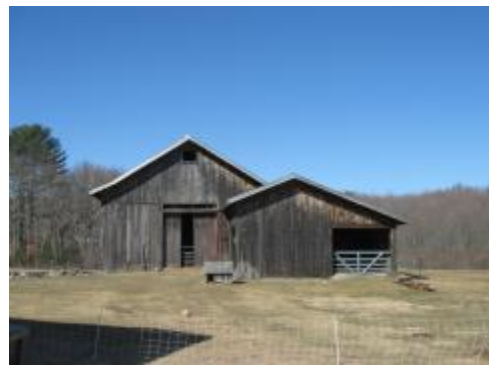
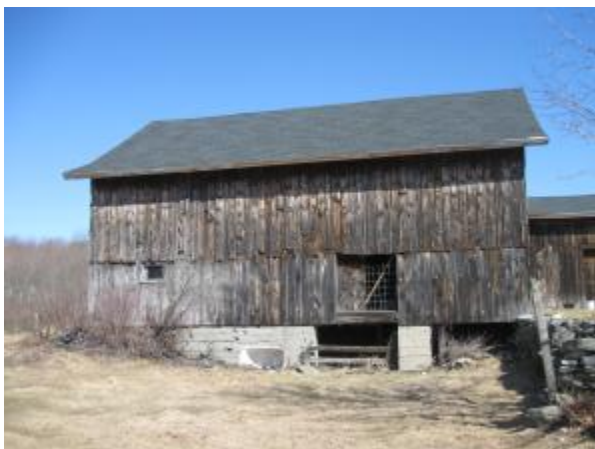
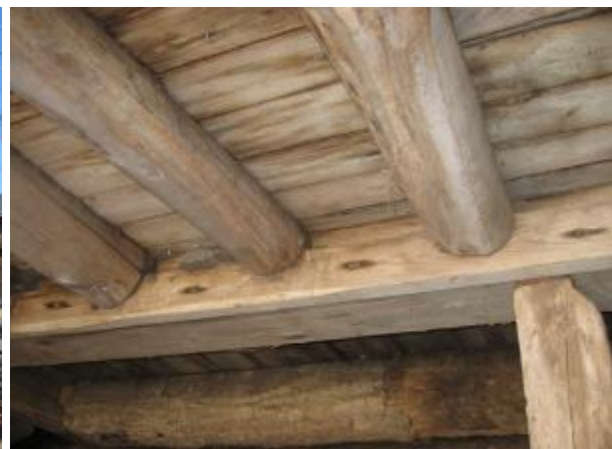
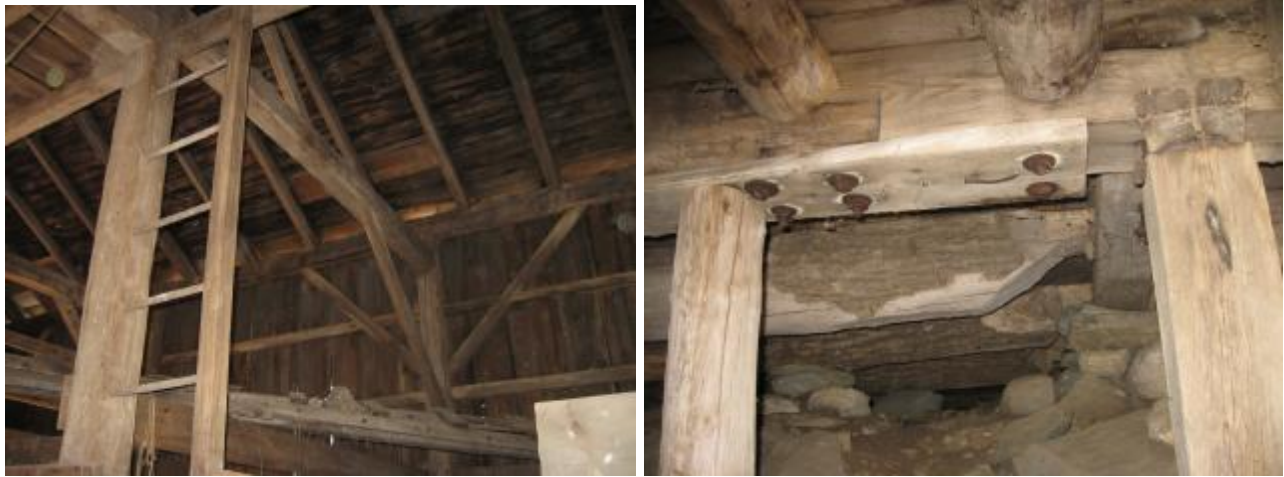
- **East Thompson Rd. Barn #2 near speedway**

Built in 1848 using wooden pegs. The farm house nearby was built in 1741 according to details given in a family bible that belonged to Humphrey Joselin. A dairy was operated here in 1870. A piggery was located in the basement..

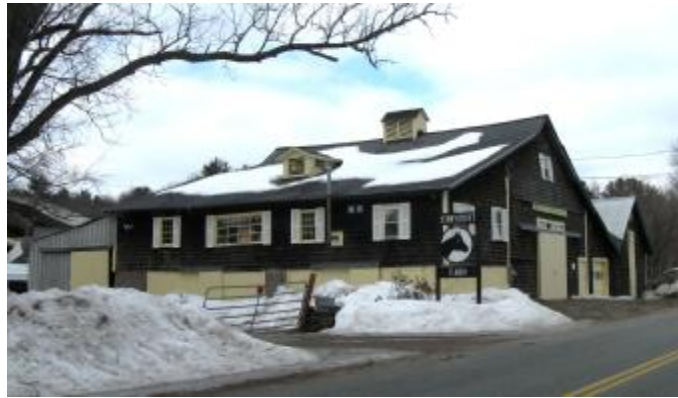
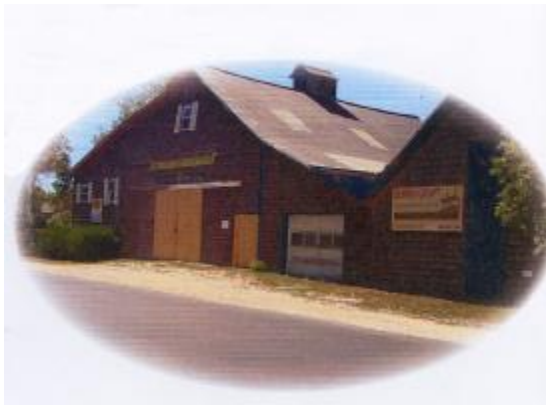
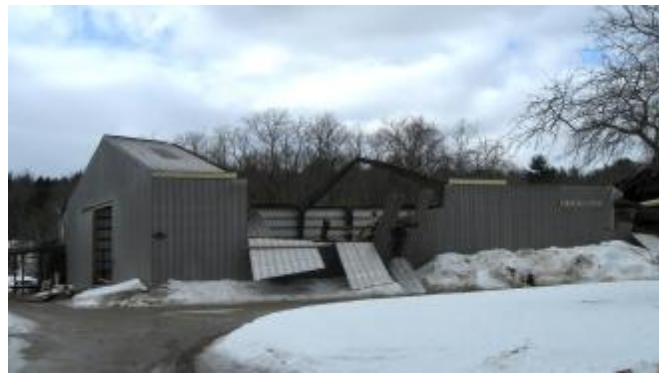
- **East Thompson Road – Sunny Croft Farm**

Picture from 2008 calendar and 2011 picture of barns including metal clad barn at rear that collapsed under the weight of snow. The modern barn was being rebuilt in the fall of 2011

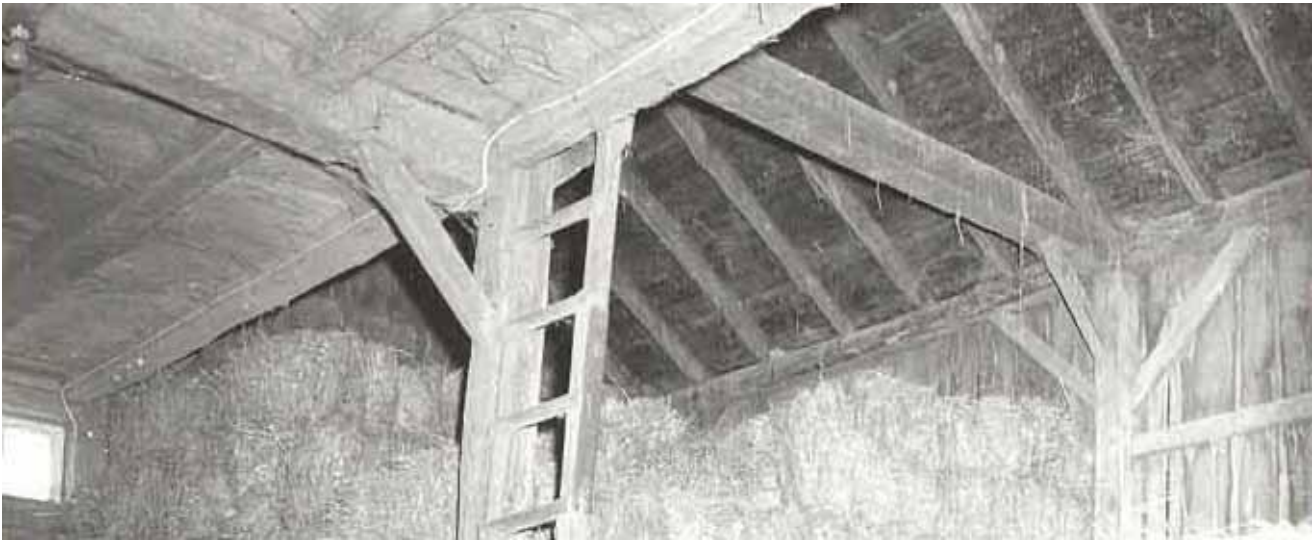
Structural details inside barn #6

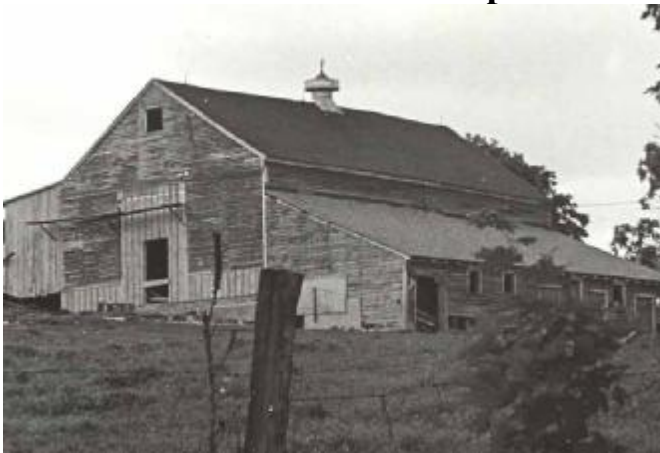
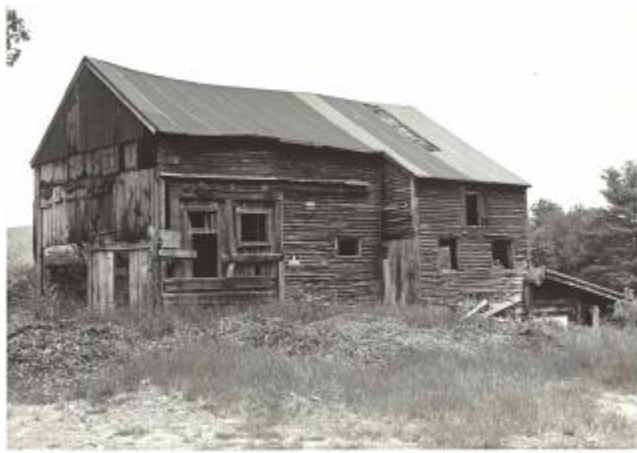
- **Barns # 7 & 8 in bad shape -- no data from 1970s**

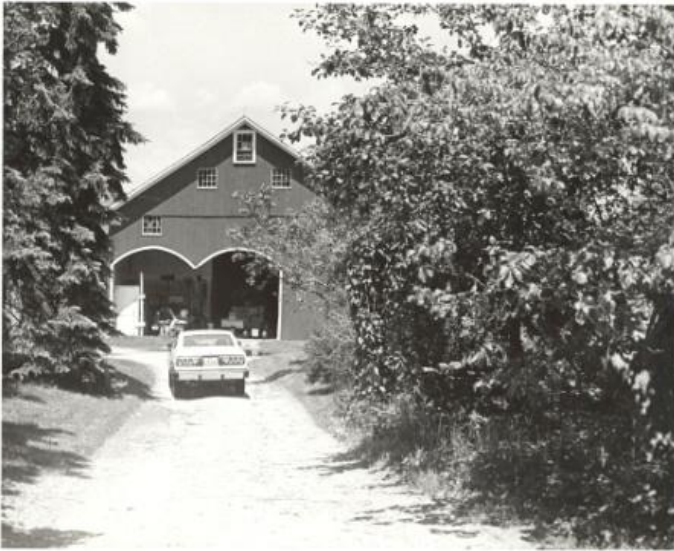
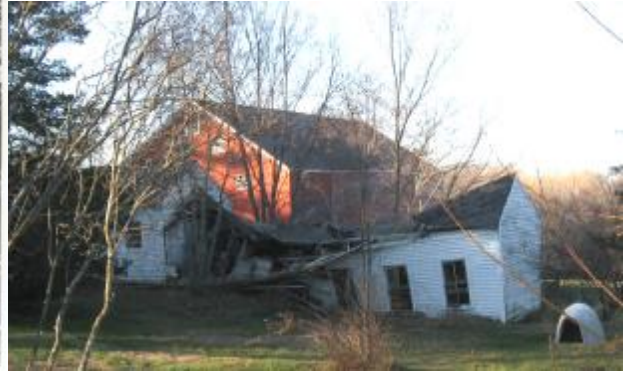
- **Haagstrom Road barn #1**

Data and B&W picture come from the prior survey Picture from the 1970s and 2011 show that this barn is used as a garage. The side building appears to have collapsed probably from the weight of snow in February 2011.

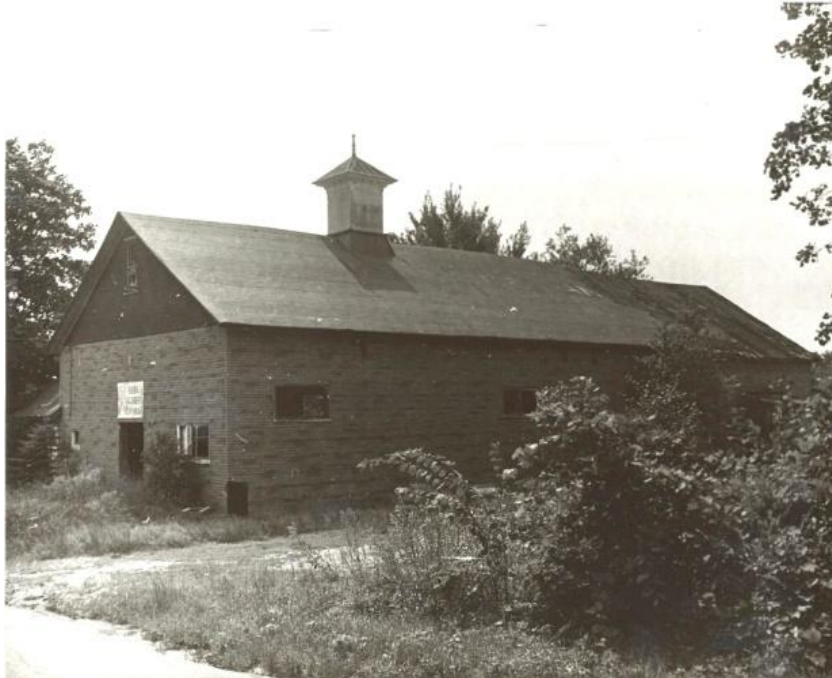
- **Quaddick Road barn #4 Barn used as play house in the 1920s**

This barn was destroyed by fire

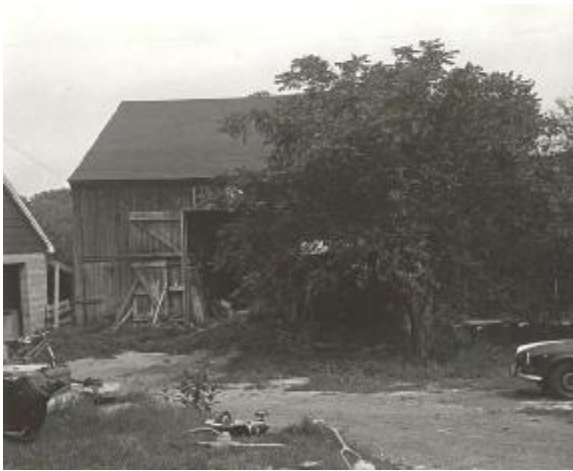
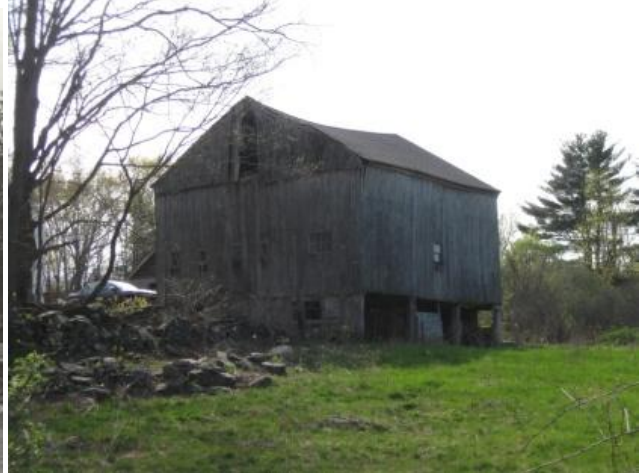
- **Quaddick barn #6 on corner with O'Leary Collapsed under snow load 2011**

Corner O'Leary Road. LENGTH: 22 WIDTH: 26 HEIGHT (Sill to plate): 13 BARN FORM: English Basement Barn
ROOF FORM: Gable Rafter Overhang, minimal ROOF PITCH (GABLE): Depressed SHEATHING: Vertical one length
DOORS: Hinged WINDOWS: Over Door BENT TYPE (ala Glassie): Continuous tie beam
ROOF FRAME: Ridge Pole, sawn Rafters continuous Rafters Squared, sawn FRAMED ELEMENTS: Sawn Up & Down Wood species, chestnut

Barn collapsed under the weight of heavy snow 2011

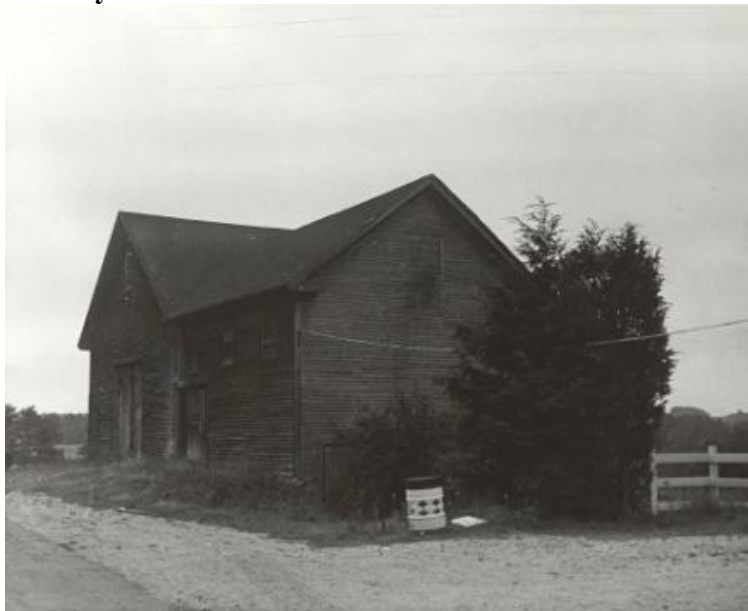
- **Quaddick Town Farm Rd. barn #2 -- demolished**

Built in 1881 this barn was formerly part of the Munyan farm. In the 1890s there was a piggery underneath the ground floor. Horses were stabled here and hay was stored. When the roof collapsed the barn was too expensive to repair and maintain. The Town picked up the debris and charged the land owner and . Ben Barrette salvaged three big chestnut timbers.

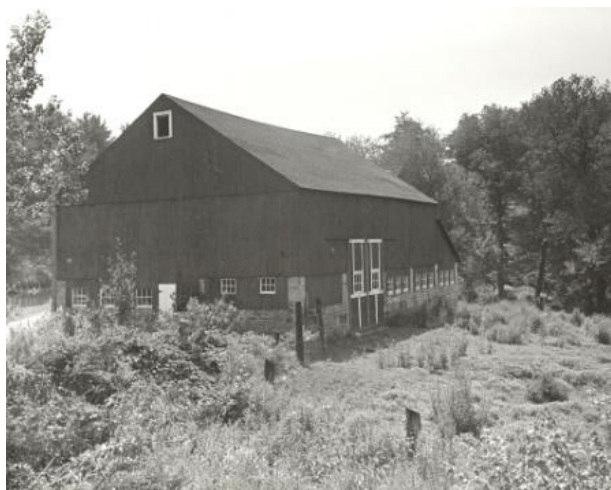
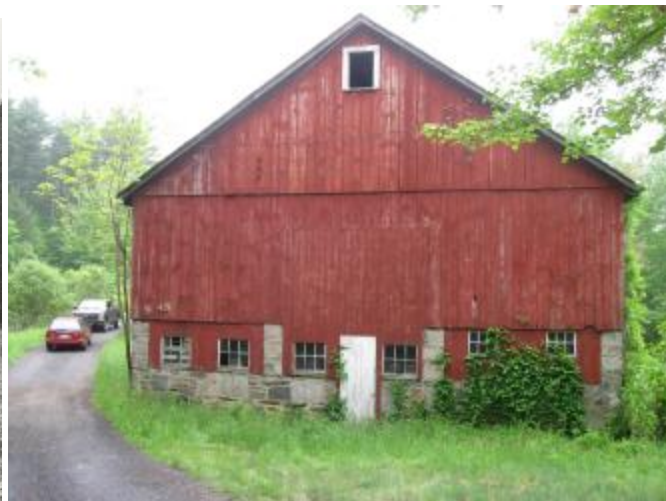
- **Route 131 barn #2**

This barn was moved onto a new foundation when the highway now Route 131 was moved to straighten the road. The timbers are over 200 years old and there has been a wood bore problem in the past but the roof is intact.. Currently used for storage and for wine making.

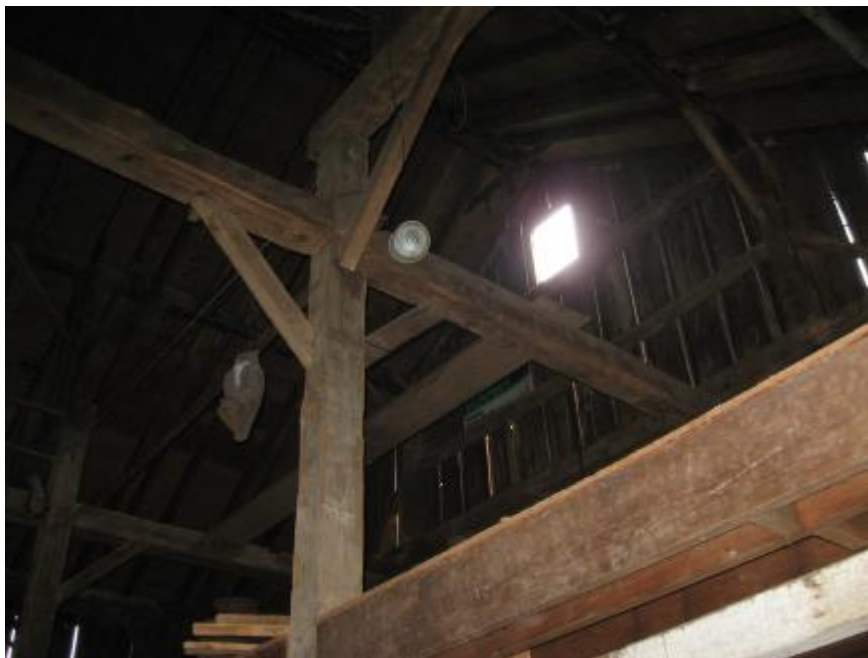
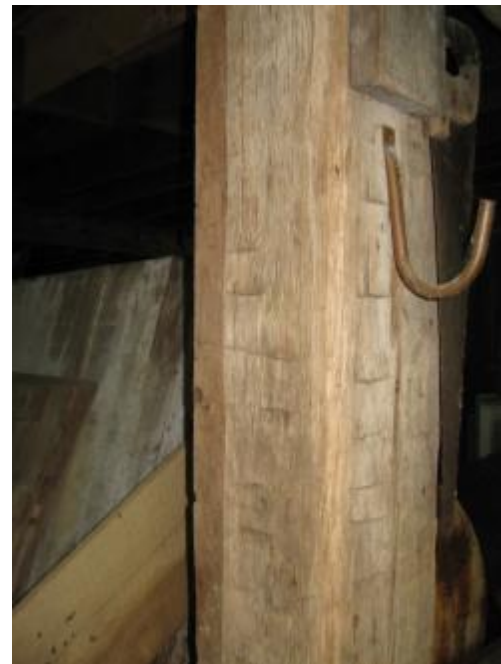
Interior of Barn #2 Route 131 used for storage and for preeing grapes and making wine.

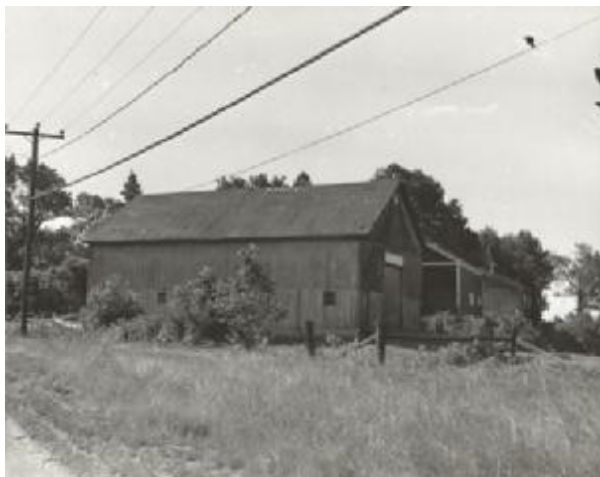
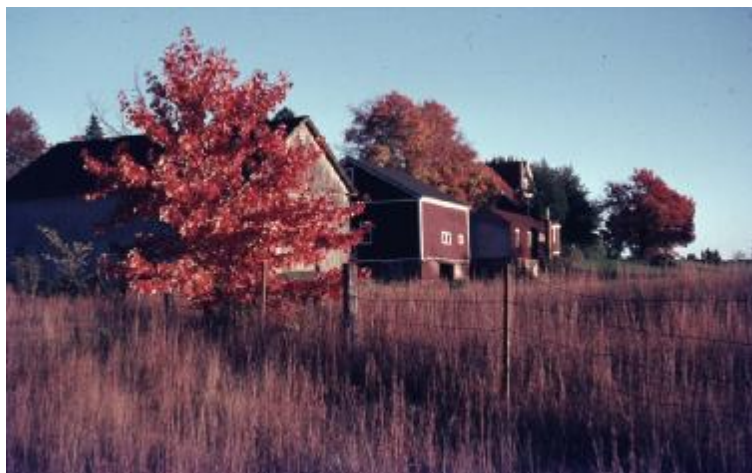
- **Route 131 barn #3. This barn has collapsed**

Above: Copy of 1970s color slide. Below: Photo in 2011 of debris from barn

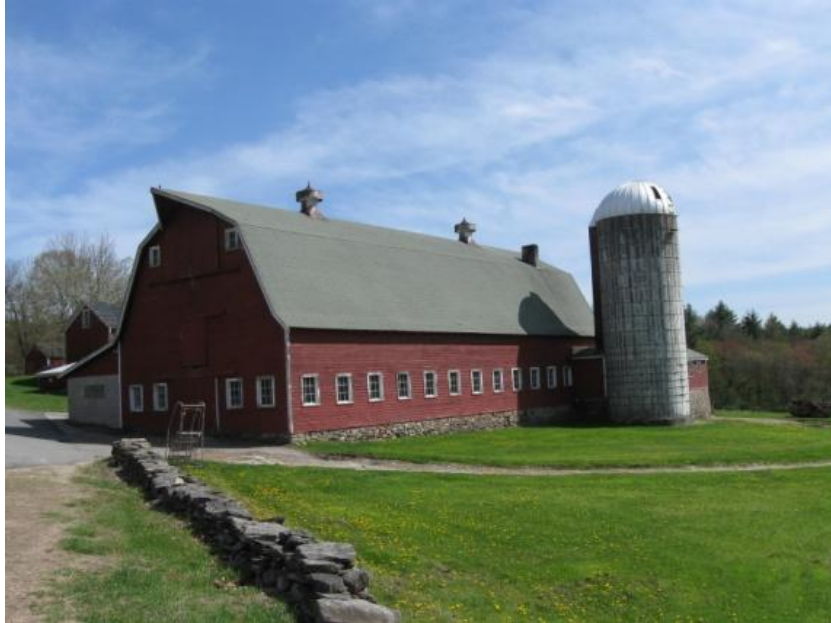
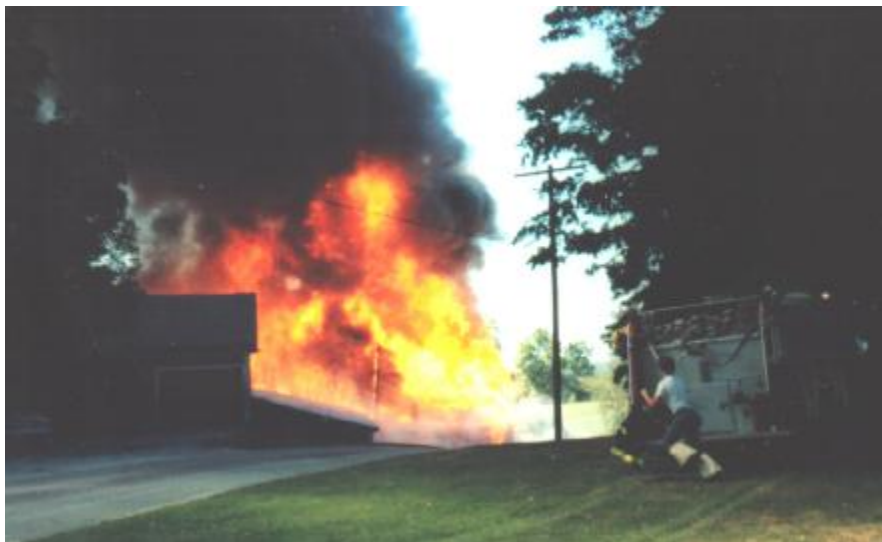
- **Robins Road barn #1**

According to Ben Barrette this barn was built using a Catalog design sometime in the 1920s. The barn was lost to fire about 1938 and was rebuilt by Henry Robbins. In 1987 a second major fire destroyed the structure which was being used a specialized wood treatment business. The current barn was rebuilt by the Barrette family.

Barn pictured prior to the 1987 fire – note the silo and an action picture of the fire Labor Day 1987

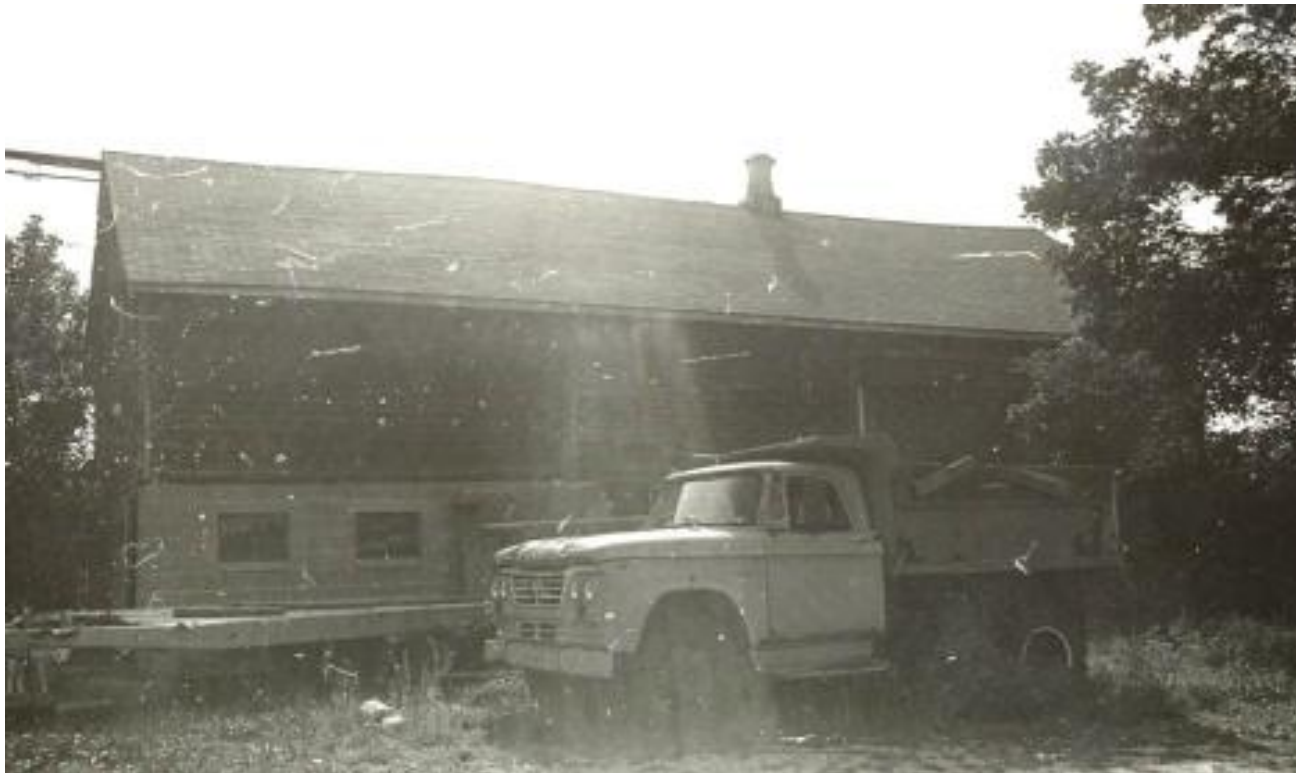
- **Thompson Road barn #1**

BARN FORM: English ROOF FORM: Gable Rafter Overhang 12" ROOF PITCH (GABLE): Depressed

SIDING: clapboard DOORS: Roll, recessed

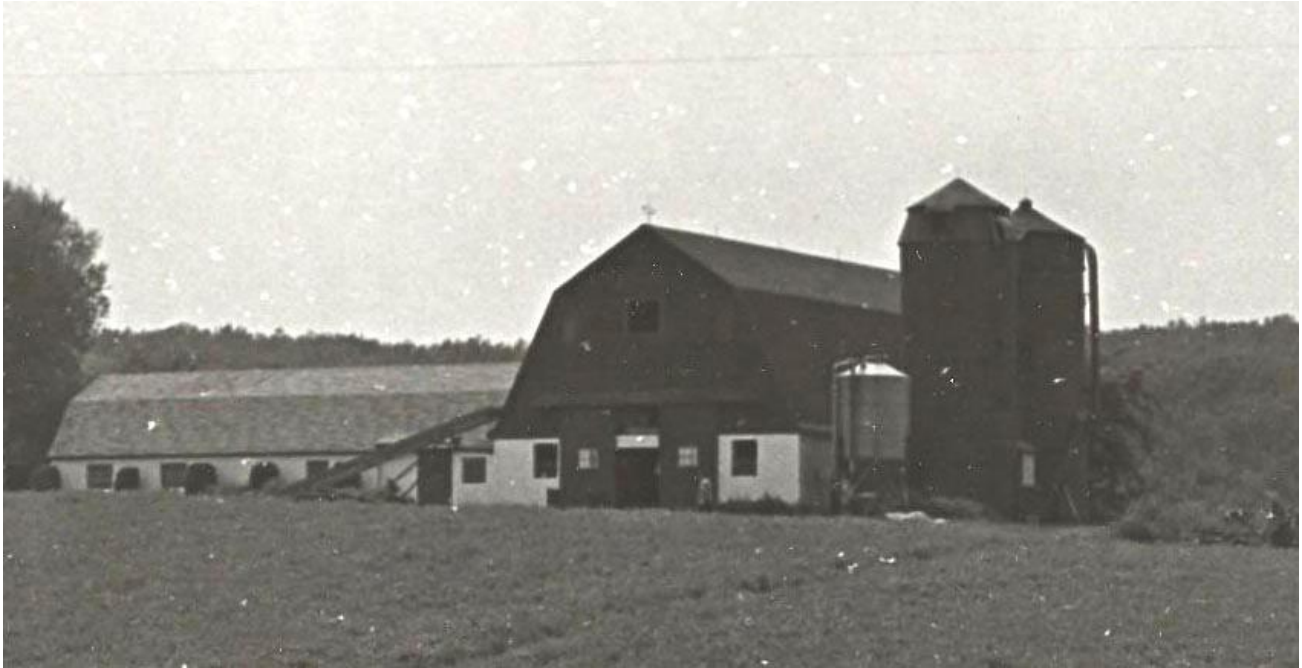
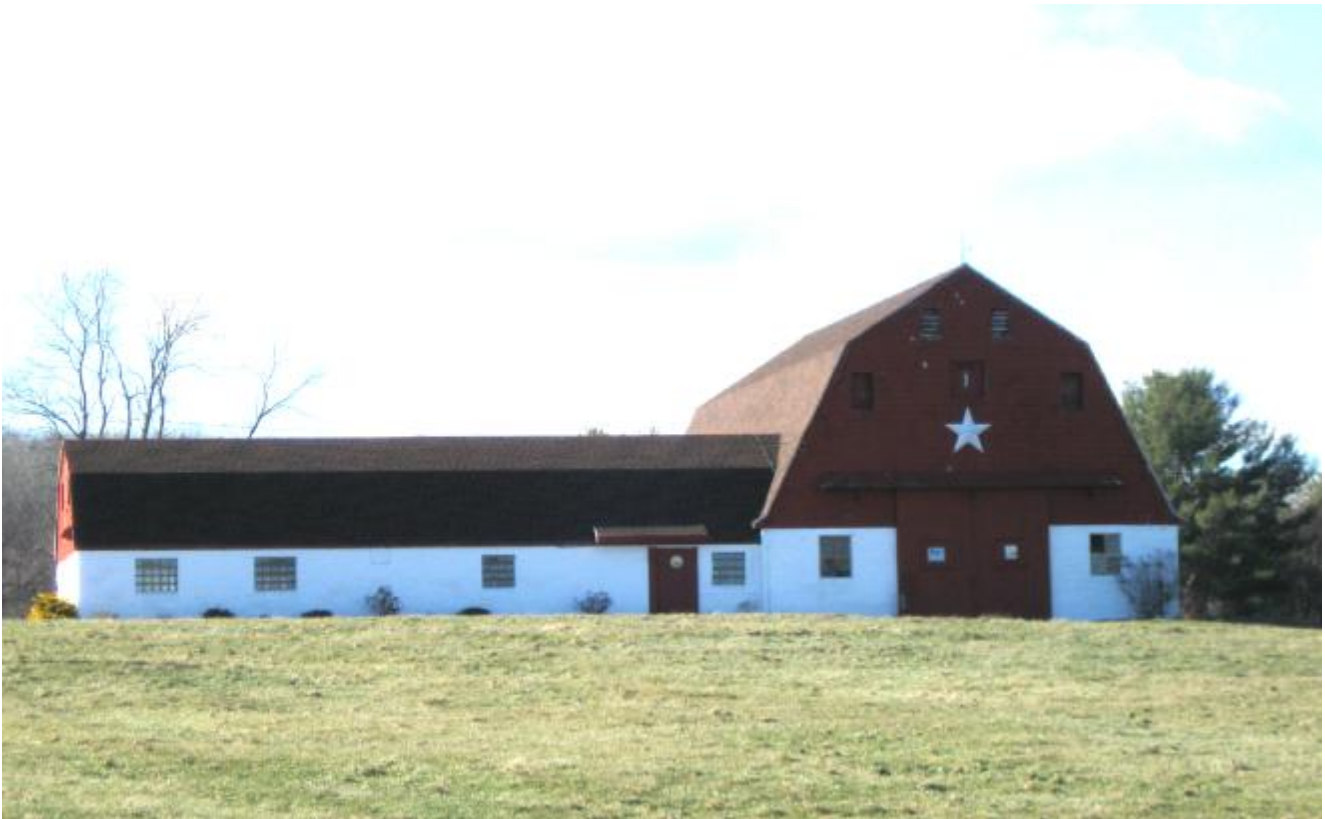
Thompson Road barn #2 built about 60 years ago and currently used to store hay

BUILDING TECHNOLOGY: Gambrel bank Across from Porter Plain Road. BARN FORM: Gable Entrance Bank, concrete block
ROOF FORM: Gambrel

Current owner stated that this barn was built in the 1920s using a catalog design similar to the proces used for a barn on Robbins Road.

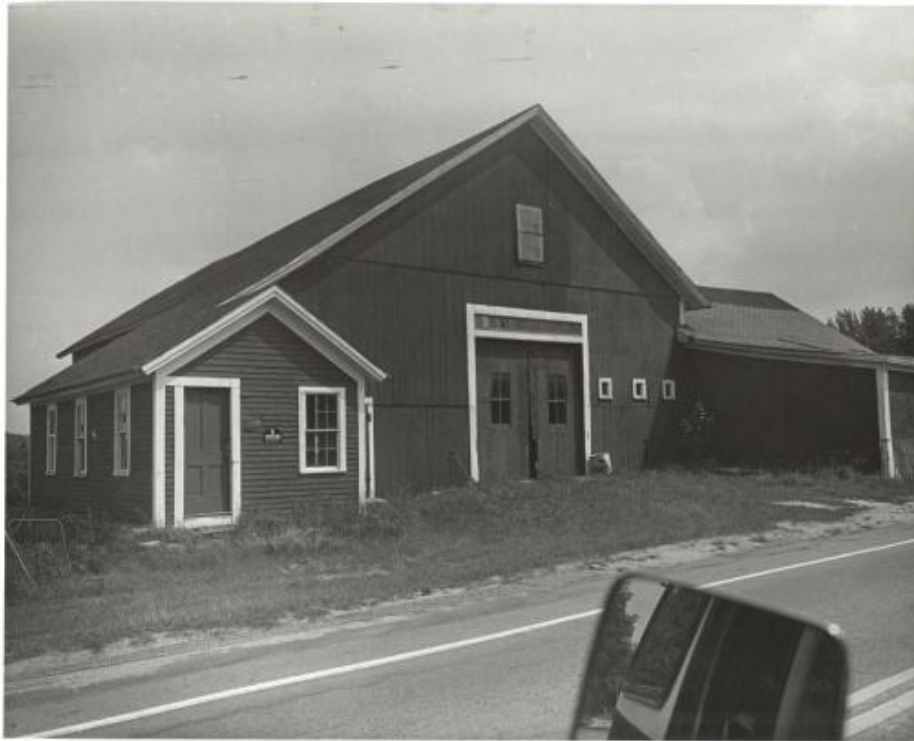
- **Thompson Road barn #3**

New England typology Gone. Across from Johnson Corrugate. No longer there. BARN FORM: Gable Entrance Basement Barn
 ROOF FORM: Gable ROOF PITCH (GABLE): Depressed SHEATHING: Vertical Ends overlapped
 DOORS: Roll, recessed WINDOWS: Single row

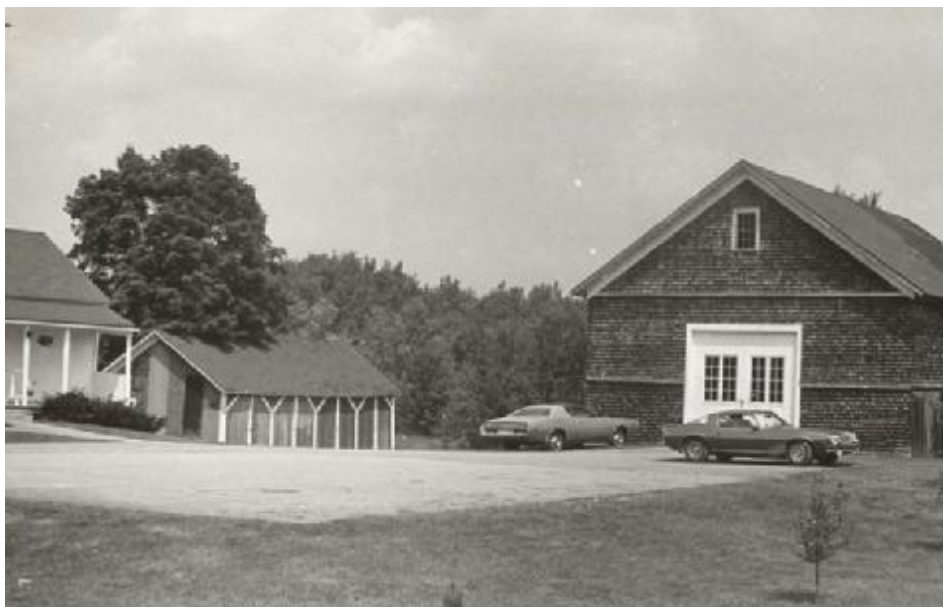
- **Thompson Road barn #4**

New England typology BARN FORM: Gable Entrance Basement Barn ROOF FORM: Gable Rafter Overhang, 12"
 ROOF PITCH (GABLE): Depressed SIDING: shingle DOORS: Roll, recessed

This barn was formerly owned by Lois Thompson and the foundation may date back to the Bixby family

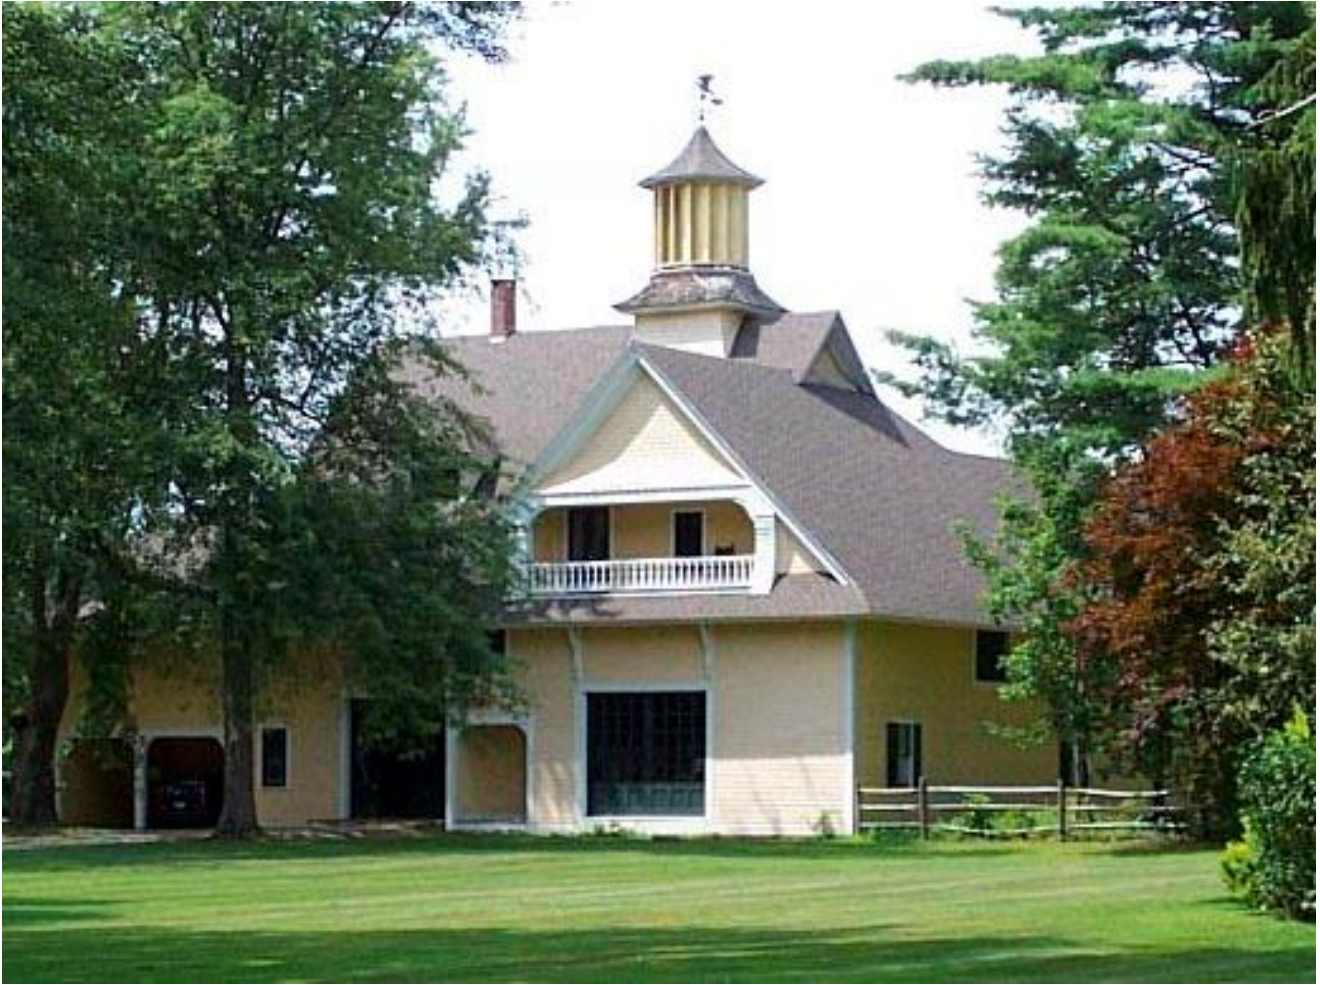
- **Thompson Road Chandler carriage house & barn #7**

This barn is associated with an elegant 19th. house on Thompson Common. The Randolph Chandler family owned it for many years and farmed here. The vertical axis windmill on the roof is a unique feature.

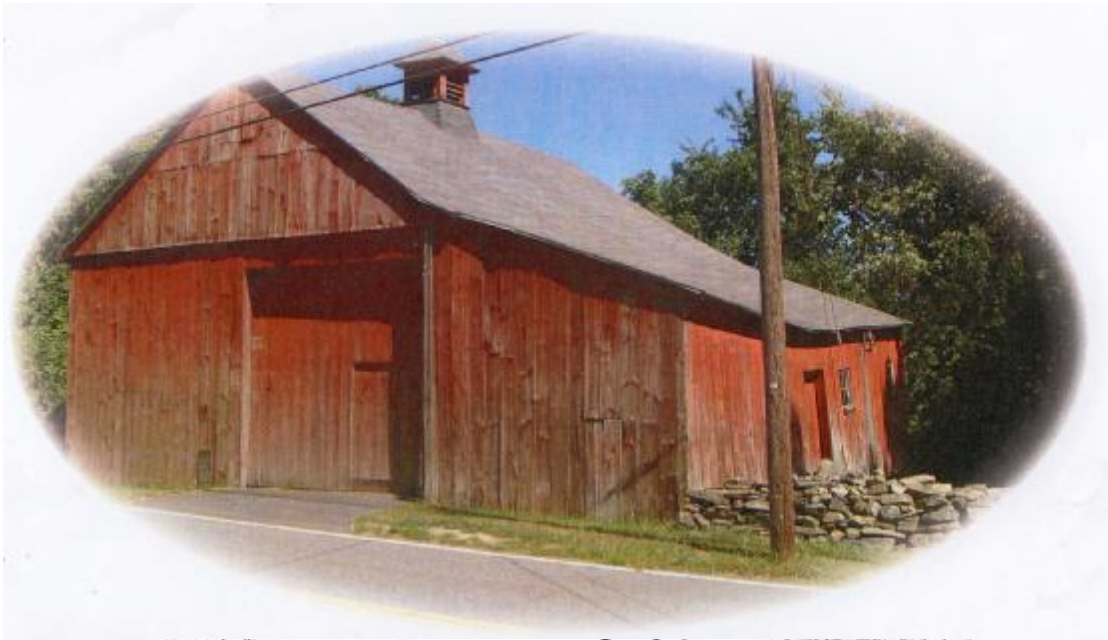
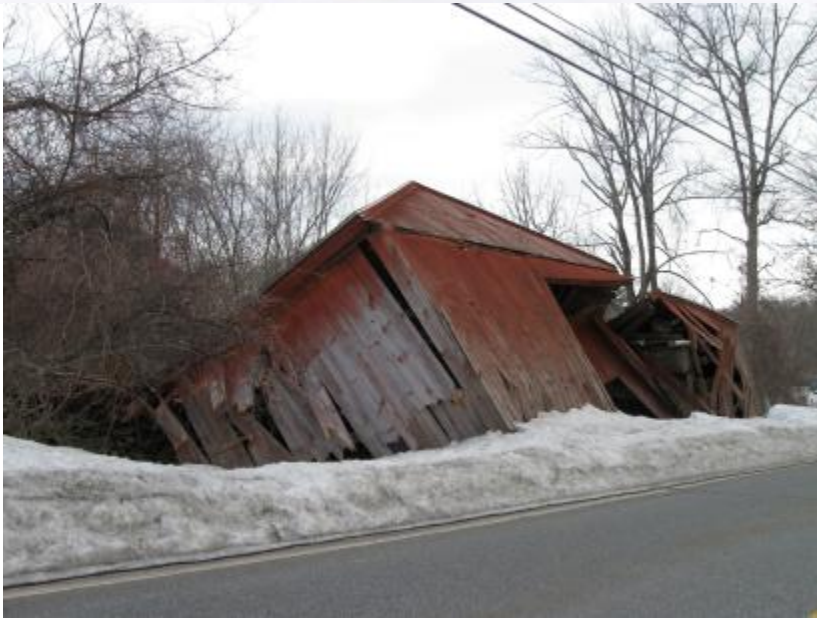
- **Thompson Road Barn # 8 collapsed under heavy snow load 2011**
Not listed in the 1970s survey. Picture from 2008 THS calendar

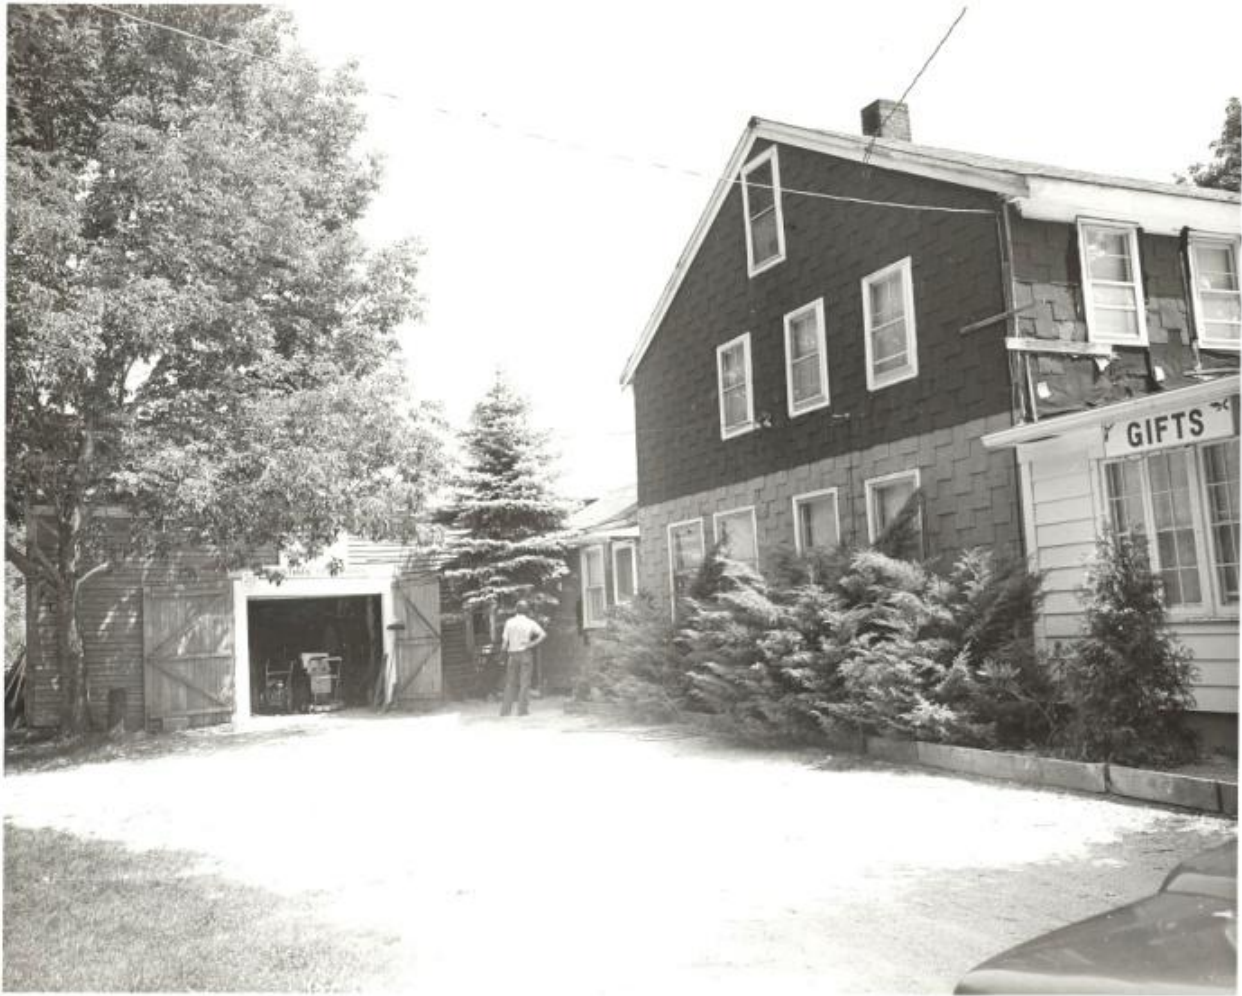
- **Tufts Road barn #1**

Small building probably a shop originally. WIDTH: 18 L IN BAYS: 4 BARN FORM: English Connected to House
ROOF FORM: Gable Rafter Overhang minimal ROOF PITCH (GABLE): Depressed SIDING: clapboard
DOORS: Modern overhead

Data and picture from prior survey. No evidence of barn was found during the 2011 survey
