Thompson Conservation Commission

**Interim collection of data and pictures of the
on significant barns identified in Thompson**

July 2013

Prepared by Commissioner Ron Tillen

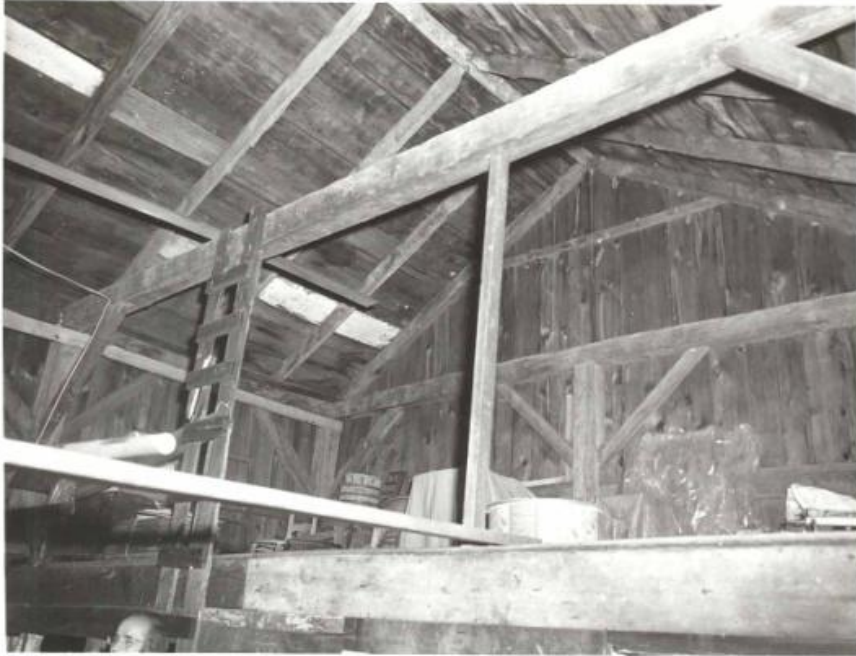
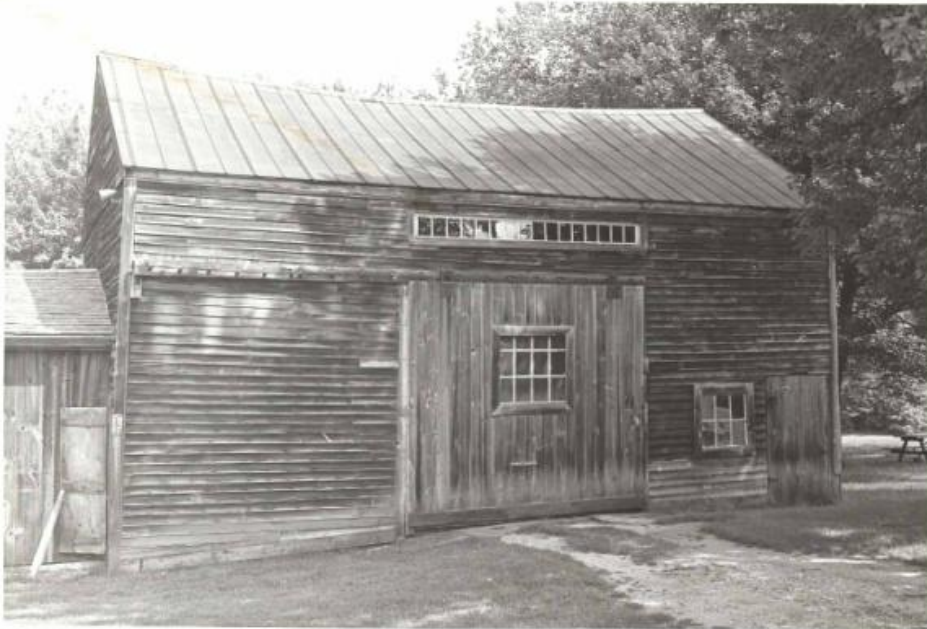
- **West Thompson Road barn #1** Methodist Parsonage site 1792

TRADITIONAL NAME: LENGTH: 30 1/2 WIDTH: 21 HEIGHT (Sill to plate): 13 Barn burned in 1834 then this barn built. BARN FORM: English ADDITION: Lean to, later added to back ROOF FORM: Gable Rafter overhang minimal ROOF PITCH (GABLE): Depressed SHEATHING: Vertical, one length SIDING: Horizontal, clapboard DOORS: Roll, outside WINDOWS: Over Door Single row FOUNDATION: Dry Stone BENT TYPE (ala Glassie): Continuous tie beam 5 sided ROOF FRAME: Ridge Pole Rafter continuous Rafters Squared, sawn FRAMED ELEMENTS: Sawn Up & Down Wood species chestnut Braces & small girts sawn Plate dadoed

Picture taken 2011 shows changes to the door and new window on left.

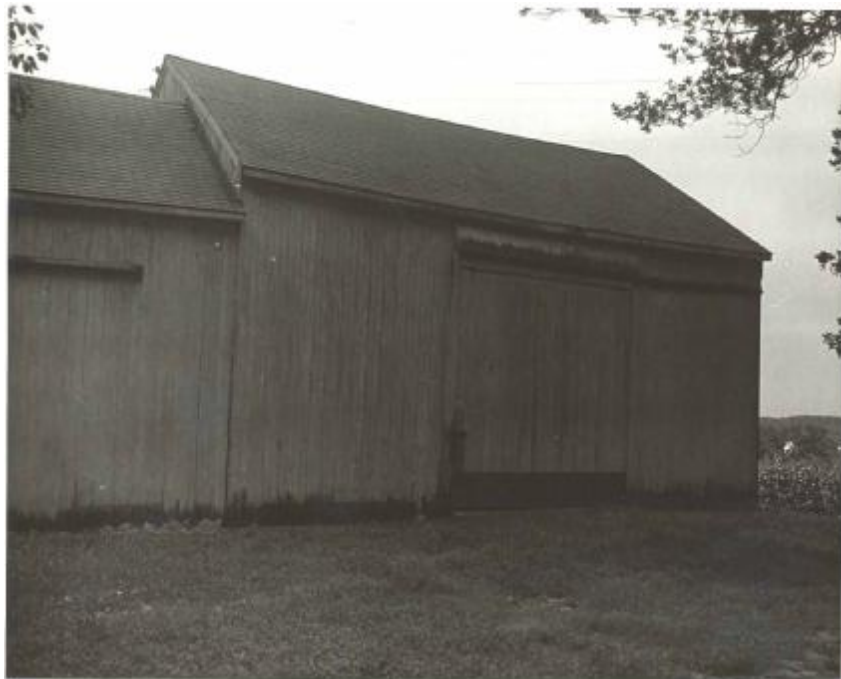
- **West Thompson Road barn #2**

BARN FORM: English ADDITION: Added Bays (L) ROOF FORM: Gable ROOF PITCH (GABLE): Depressed
SHEATHING: Vertical DOORS: Roll, outside
Data and picture from 1970s survey but the barn was not found in the recent survey.

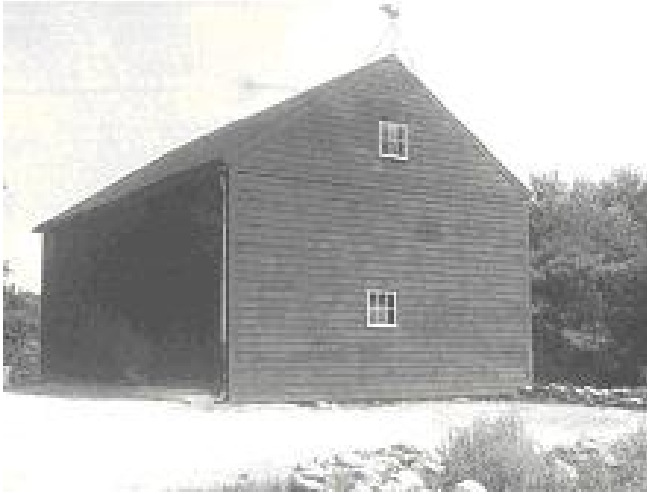
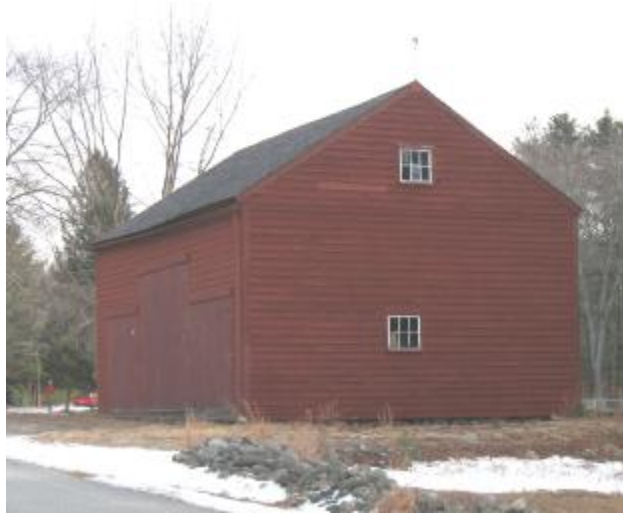
Wilsonville barn #1

English topology BARN FORM: English ROOF FORM: Gable Rafter Overhang minimal Horizontal clapboard

Old and new pictures showing no change over 40 years
